# Crossing a landslide area by a motorway

## ABSTRACT

A 1.5 km long stretch of a motorway built at midheight of a valley eroded by an intermittent river, was almost completed in 2009. Budgetary restrictions led to a halt in construction. In the period 2009-2018, the motorway experienced severe damage, concentrated in three tributary shallow valleys, where the motorway was supported by compacted soil embankments.

The “valleys” were, in fact, ancient landslides reactivated by the weight embankment of the embankment. The damaged embankments were substituted by bridges supported by pile foundations designed to resist the thrust of the active landslides. The bridges were completed by pile walls to improve the stability of the landslides. The construction of the wide roadway platform (40 m) required excavations at the mountainside, embankments at the riverside, additional stabilizing measures by anchored resisting walls, and systematic drainage.

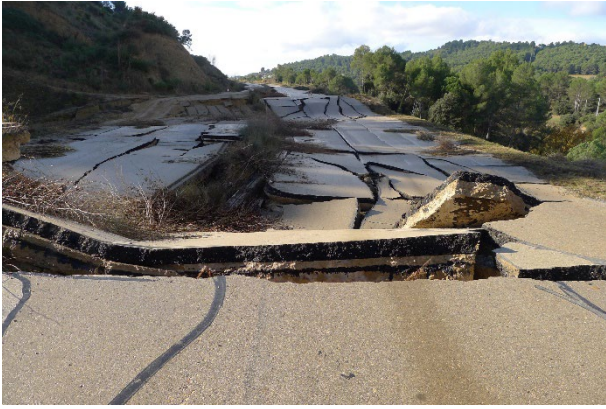
in 2009. However, budgetary restrictions led to a halt of construction works for a period of 9 years. When work resumed the platform showed, in several locations, major damage (Fig. 2).

**Figure 2.** Failure in “zone 5”.

The original designers of the motorway decided to cross three small valleys, tributaries of the main river parallel to the road, using embankments and conventional surface drainage to evacuate the rainfall flows coming from higher elevations. The massive failure shown in Figure 2, in 'zone 5' (Fig. 1) and other local failures and deformations led to a detailed geomorphological evaluation of the entire area. The failure of section 5 was a reactivation of a landslide under the weight of the road embankments and, probably, a modification of hydrogeological conditions. Figure 1 shows an

A decision was taken to replace the three embankments with bridges whose abutments were located outside the limits of the landslides. Additional decisions were to support the bridge pillars on deep foundations and to stabilize the three landslides by pile walls (Figure 9).

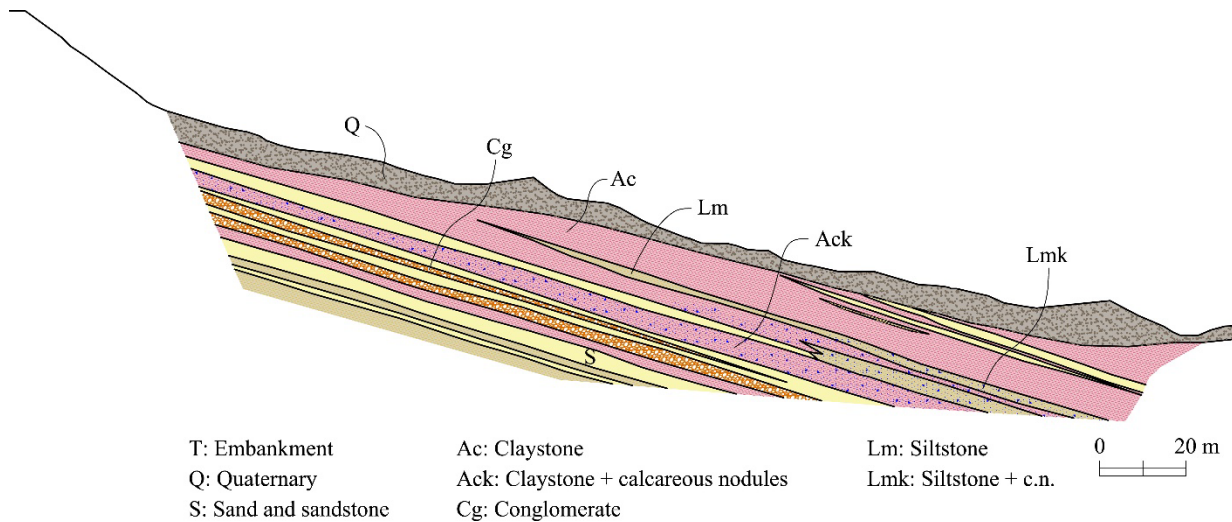
Figure 3 is a cross-section of the valley slope in the position shown in Figure 1 (chainage pK 4+719). The slope angle in the central-lower part of the valley is close to 12°. In other zones of the damaged motorway, the platform required excavation of the slope (mountain side)

**Figure 3.** Central profile in zone 5.

Figure 3 shows a typical sequence of Miocene sand, sandstone, conglomerates and claystone layers in the area. They are tilted and dip angles match the topographic slope. The interpretation is that the topographic slope is a consequence of landsliding, probably occurred in quaternary times, triggered by the excavation of the river channel. A mantle of quaternary colluvial soils, -4 m thick in upper elevation and 6-7 m thick close to the river, covers the tertiary materials. Landslide failure surfaces follow contacts between hard (sandstones, conglomerates) and softer clayey layers, including the quaternary cover.

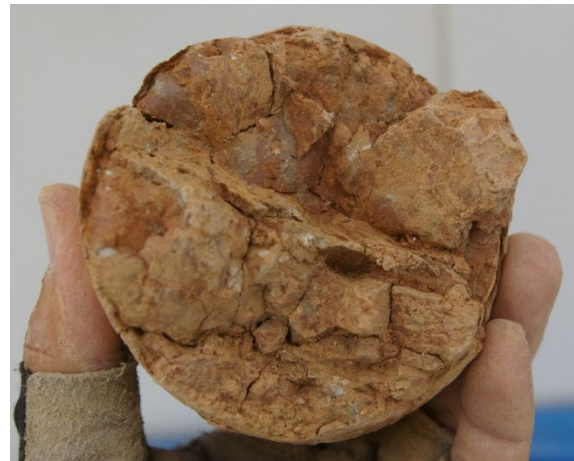
of the valley slopes. Figure 4 is an example of a sheared surface in a stiff claystone. These features were often found.

**Figure 4.** Recovered specimen of striated shearing surface in a claystone material.

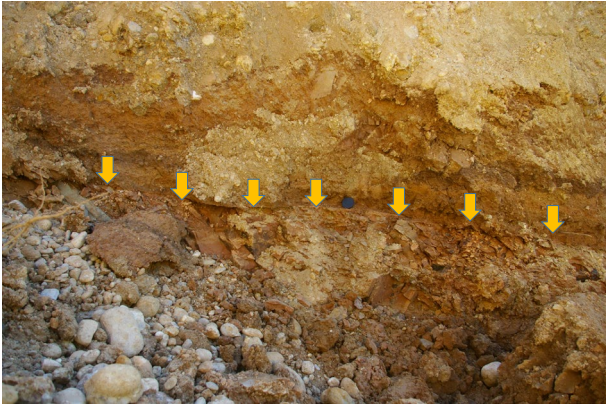
The excavation carried out in some locations offered the opportunity to examine in more detail the morphology of shearing surfaces. Figure 5 is a nice example. Figure 6 shows a sample of the surface with very distinct striation in the direction of a sliding motion. The sample was tested in a shear box by aligning the shearing surface with the shearing plane of the box. The measured residual friction angle reduced to  $12^\circ$ . The clay had, in this case, a high plasticity:  $w_L = 46$ ,  $IP = 20.5$ .

**Figure 5.** Shearing surface visible in an excavated face.

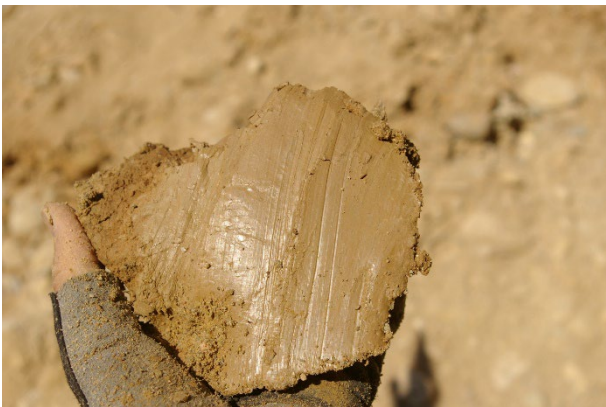
**Figure 6.** Recovered specimen showing the striated shearing surface indicated in Figure 5.

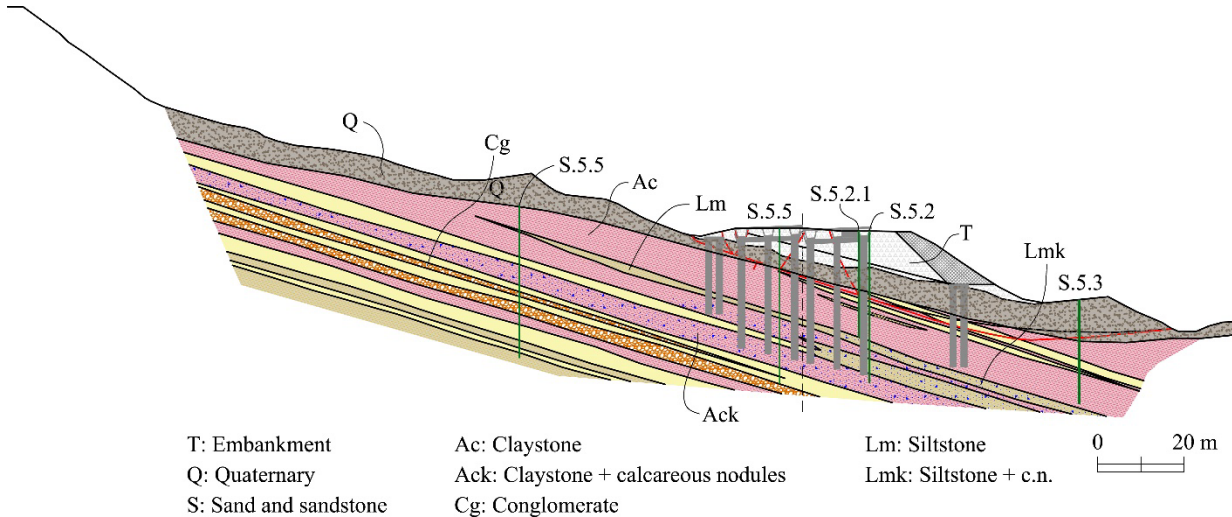
Figure 9 shows the position of inclinometer tubes S5.3, S5.2 bis, S5.2.1 and S5.5 in a transverse profile, centered in zone 5. Inclinometer's readings include systematic and random errors that should be accounted for. Mikkelsen (1996, 2003) and Stark and Choi (2008) describe the systematic errors and procedures to deal with them. The drift error, explained by deviations from verticality of accelerometer sensors, is the most frequent

**Figure 9.** Central cross-section of Zone5 showing the original embankment, the piled bridge structure , the position of the two pile retaining walls and the position of piezometers

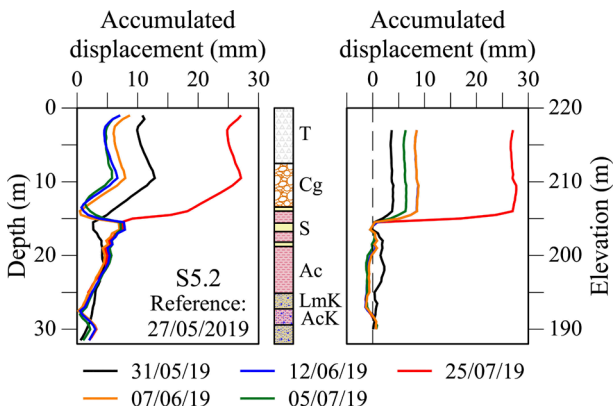
one. Inclinometer data was systematically corrected in this study. Figures 10, 11 and 12 show measurements of inclinometer S5.2 and its replacement due to damage caused by construction works and excessive shearing displacements. The figures show a comparison of non-corrected and corrected displacements for three time intervals spanning the dates 27/05/2019 to 18/01/2021

The landslide in zone 5 was active and moving down at a velocity of 13-14 mm/month (Fig. 10) at the beginning of comforting works.

**Figure 10.** Inclinometer S5.2. Left: Uncorrected; right: corrected

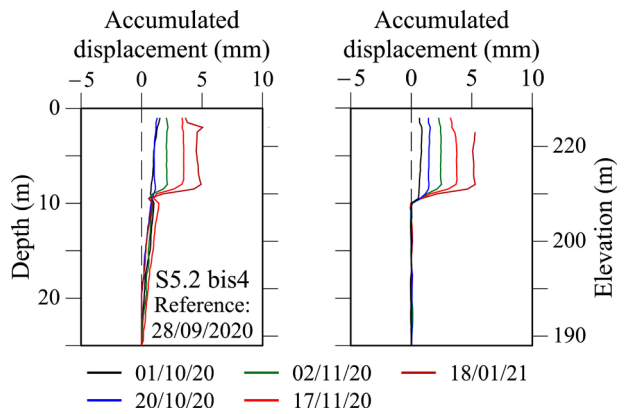
**Figure 12.** Inclinometer S5.2bis4. Left: Uncorrected; right: corrected

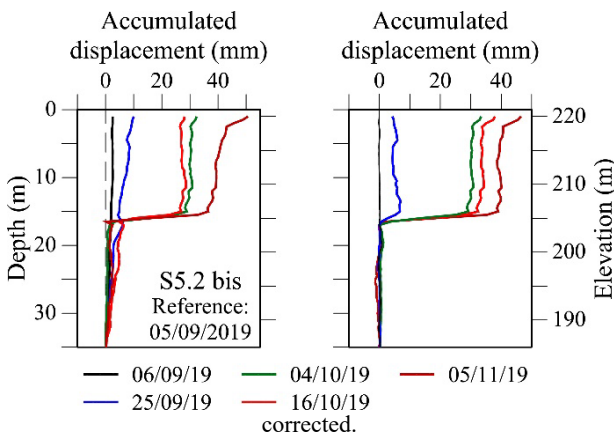
**Figure 11.** Inclinometer S5.2bis. Left: Uncorrected; right: corrected

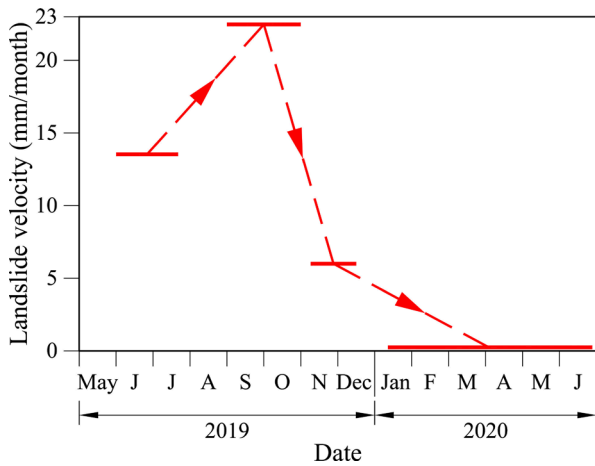
Figure 13 shows the evolution of landslide velocity during the period of bridge construction. The foundation piles and the removal of the embankment explain the reduction of landslide displacement rates. The landslide reached a very small creeping rate during the first months of 2022. The slide was further stabilized by building two pile walls in the position shown in Figure 9. The figure shows the position of the basal sliding surface, determined by inclinometer data, close to the contact between the quaternary layer and the miocene substratum. The upstream pile barrier was a protection from the potential instability of the quaternary deposits at higher elevations.

Figure 13. Evolution of landslide velocity in Zone 5.

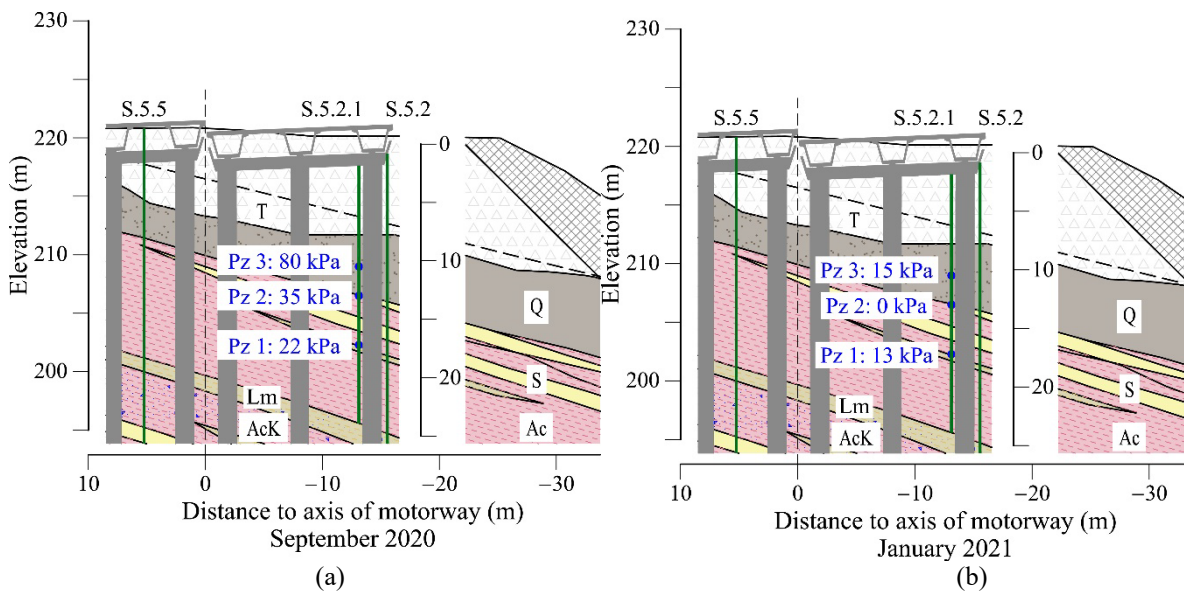
Vibrating wire piezometers located in the vicinity of the inclinometer borings (Fig. 14) provided a continuous record of water pressures in the transition from the quaternary cover and the miocene substratum. Figure 14a (September 2020) shows high water pressures in the lower part of the quaternary layers and a significant reduction of pore water pressure in the upper miocene

layers. This behavior may be explained by the high conductivity of sandstone strata below the quaternary soils. Water pressures reacted fast to precipitations. This is shown in Figure 14b, which shows a significant reduction in measured pressures few months later (January 2021). This behaviour and the sequence of pervious and impervious layers dipping towards the river suggested that the procedure to reduce water pressures in the entire unstable area crossed by the motorway was to communicate the layered structure by vertical drains. Hopefully, water will flow downwards toward pervious sandstone and conglomerate layers and, eventually, towards the stream bed. This procedure was deployed in the inter-zones between the bridges that were also affected by instabilities.

Figure 14. Piezometric measurements. (a) September 2020; (b) January 2021.

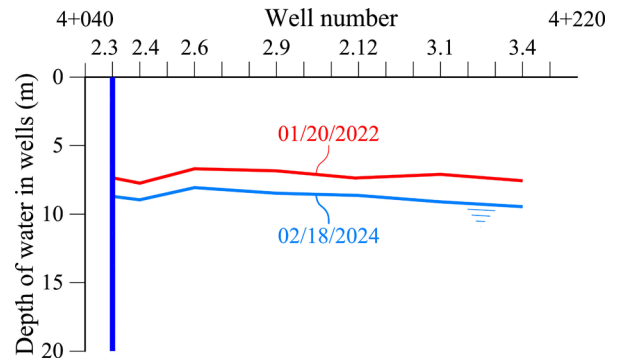
Figure 18 shows the measured water level in some drains protecting the road platform from pK 4+020 to pK 4+210. The first measurements (January 2022) indicated depths of free water close to 7 m. Two years later the measured depths ranged from 8.5 to 9 m. This range of levels is marked in Figure 15. In the road stretch from pK4+360 to 4+460 all the drains remained dry. This is a positive situation because of the instabilities observed originally in this section.

**Figure 18.** Water depth measured in drainage wells, at two times, in the zone between pK 4+020 and pK 4+210.

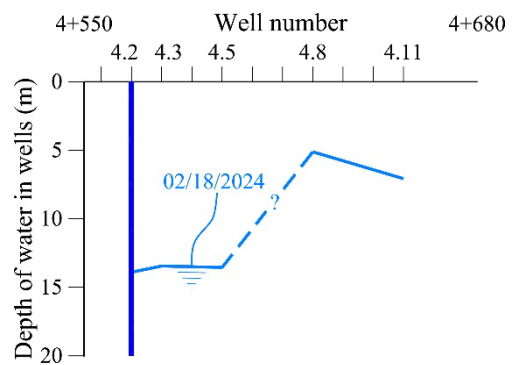
Figure 19 shows the measured water depths (February 2024) in drains installed in sections pK4+550 to pK4+660. This is a critical location because of the slope failures triggered by the excavations (mountain side) performed during the initial construction of the

**Figure 19.** Water depth measured in drainage wells, in February 2024, in the zone between pK 4+550 and Pk 4+660

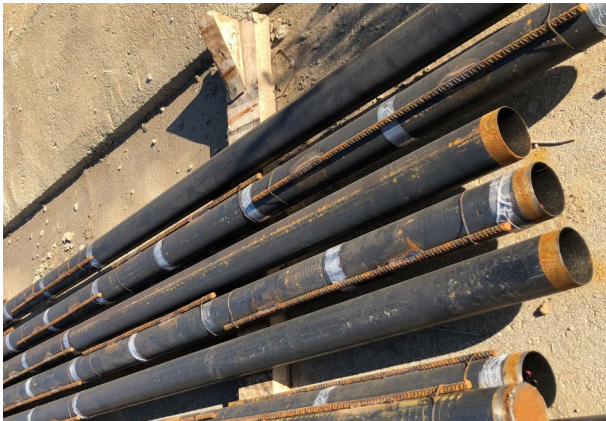
The anchors shown in Figures 15, 16, and 17, and also in other locations, are of a ‘permanent’ type. Essentially, this is achieved through long-term protection of the high-strength cables from corrosion. In the anchoring zone (bulb), this is achieved by inserting an impervious tube protection between the borehole wall and the set of cables. A (smooth) steel tube was selected for this purpose. Preliminary pull-out loading tests indicated a failure of the ‘adhesion’ between the steel tube and the cement injection. The “adhesion” concept is somewhat misleading because the shear strength developing at the interface between the steel tube and the surrounding hardened cement grout is dominated by a frictional strength that is controlled by the normal stress to the interface and therefore, to a large extent, by the dilatancy of the steel-grout contact. Pressurized grout injection also contributes to increasing the available friction at interfaces. The problem was solved by welding corrugated bars (Figure 20) to the protection tubes (Figure 21).

**Figure 20.** Corrugated bars welded to the protective tubes of the grouted bulb of anchors

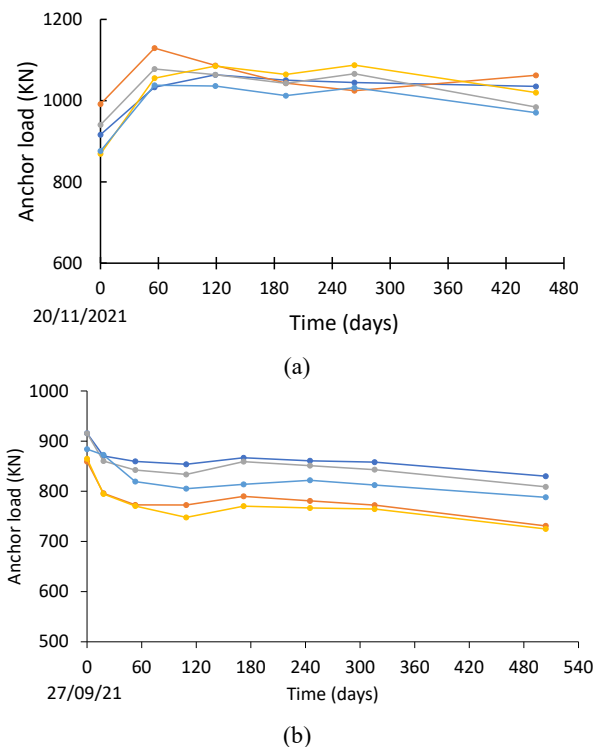
Figure 22 shows the evolution of the applied anchor loads in two different zones. In Figure 22a, the anchor loading was applied in two steps in a time interval of 60 days. A small to moderate reduction in the load is considered correct. This was the case for the monitored anchors. However, a proper diagnosis would require a much longer monitoring time. Maximum anchoring loads were set at 60 % of the limiting tensile strength of the steel cables to account for any potential increase of the required stabilizing anchor, although this does not seem likely in the future in view of the measured response so far.

**Figure 22.** Evolution of anchoring loads in a few anchors installed in two zones of the unstable area: a) After a two-step application of the design load, the anchor load is essentially maintained after 16 months of monitoring. b) Moderate decay of anchor load in a different zone.
