Record of long-term field observation of large-scale cutting slope

Shotaro Hijikata¹, Reiko Kuwano², and Hirotake Nakamura³

ABSTRACT

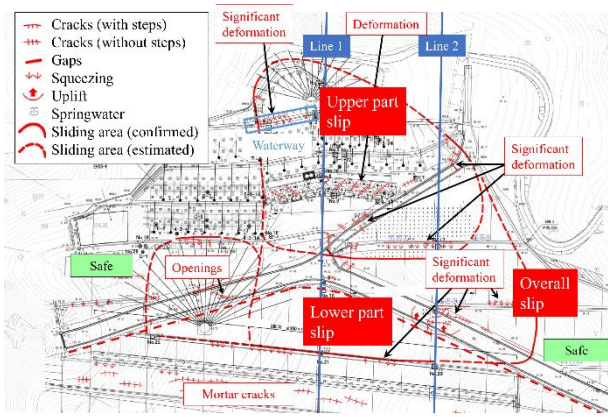
Figure 6. Schematic of landslides and deformations.

The deformations and slip surfaces estimated in 2017 are shown in Fig. 6. Surface deformations were visually observed over a wide area of the slope, and four patterns of slip surfaces were inferred to exist: upper slip, overall slip, lower slip, and small-scale slip.

An overview of the deformation conditions at site A as of 2017 revealed many longitudinal cracks in the waterway above the cast-in-place concrete piles and pushing out of the concrete at the top of the waterway on the 1:2.8 slope below the piles (Figs. 7 and 8). The cracks were observed on the west slope and above the steel pipe piles. The longitudinal cracks in the waterway occurred at the head of the center of the landslide, and the pushing phenomenon occurs at the toe of the slope. Based on the distribution of these deformations and the results of field observations, landslide blocks in 2017 were classified as the upper and overall slips. Furthermore, upon inspection, it was found that there were joint openings on the side road situated at the center of the slope and cracks in the mortar spraying on the slice-cut slope due to squeezing (Figs. 9 and 10). Based on the observed distribution of these deformations and field observations, it was concluded that the lower slip occurred between the upper and lower piles. The joint opening on the side road was estimated to be the start of a slip line, while the pushing was the end. Small-scale slides, producing minor deformations, were not included in this study.

The accelerated displacement of GPS-1 (Fig. 19(a)~(c)), the sudden observation of a slip surface at a depth of around 9 m in H-4 (Fig. 19(e)), cracks in the side road (Fig. 9) and pushing-out deformation in the slice cut (Fig. 10) suggested that a new lower slip had occurred as shown in Fig. 6.

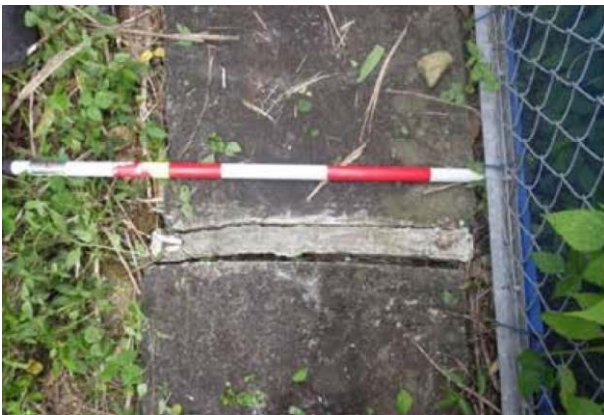
Figure 7. A vertical crack along the mortar joint of the waterway at the upper part of the slope.

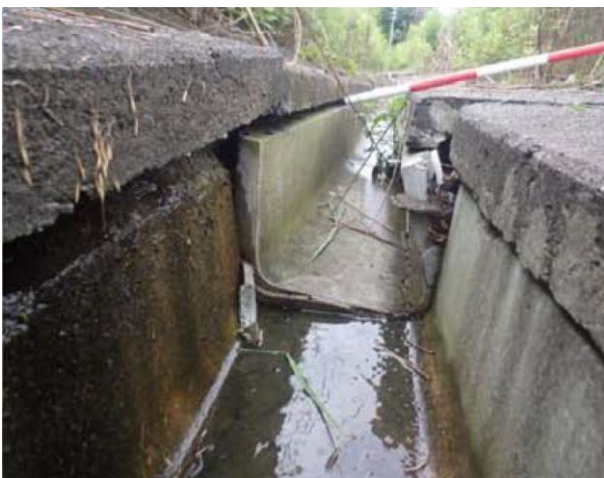
Figure 8. A waterway block subjected to squeezing at the lower part of the slope.

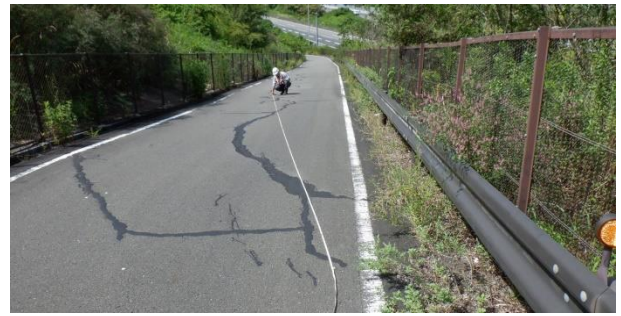
Figure 9. Joint cracks on the side road.

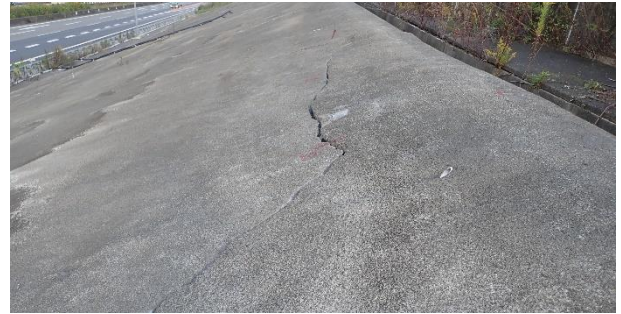
Figure 10. Cracks of the mortar sprayed slope at the lower part of the slope due to squeezing deformation.

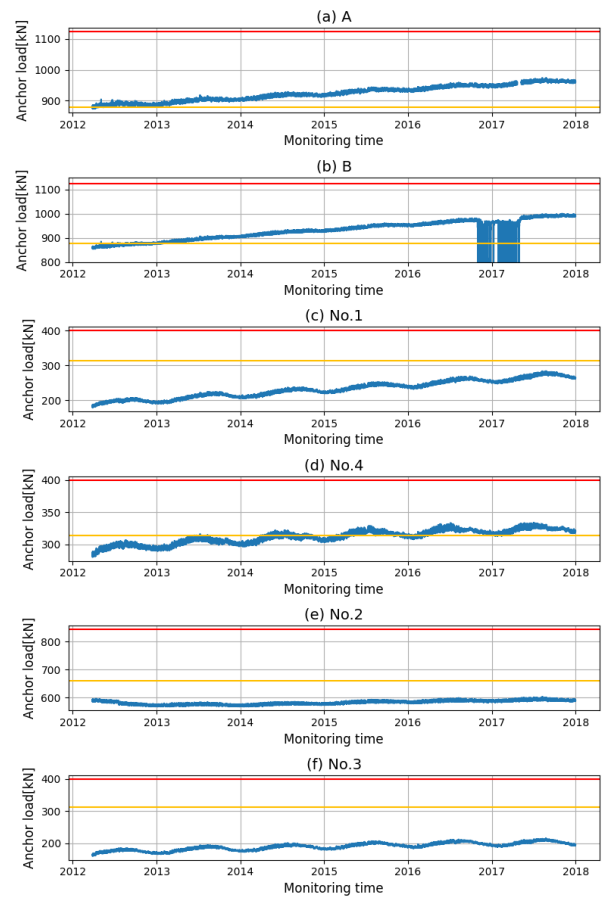
cracks at the top edge of the connecting concrete beam of the pile-head ground anchors and at a small section of the slope surface. The hairline cracks, measuring 1 mm or less, were oriented longitudinally at the top edge of the pile-head connecting concrete. The load had changed at pile-head anchors A and B (fig. 4), as demonstrated in Fig. 12(a) and (b), indicating a continuous increase. While hairline cracks were present in 2011, prior to the installation of pile-head anchors, the number of cracks had risen, and some appeared fresh, indicating that the deformations cause continuous increase in anchor loads. If the trend of the anchor load changes continued, it was calculated that it would take seven years for anchor A and 15 years for anchor B to reach 90% of the yield load, which was the emergency system standard value. Thus, it was necessary to remove the load from the pile-head anchors. The manager of this cut has established a response category when monitoring the displacement and load gauges, which is indicated by the yellow and red lines in the graph. If the tensile force exceeds the yellow line, observation data are examined. If they progress to the red line, the preparation of countermeasures is considered. If the load reaches the red line, countermeasures are implemented urgently such as counterweight fills.

In terms of the ground anchor load gauges near the cast-in-place concrete piles, we noted that there were anchors, such as No. 1 and 4 (Fig. 4) in Fig. 12(c) and (d), where the load tended to increase, while other anchors, such as No. 2 and 3 in Fig. 12(e) and (f), showed no problematic variation. This observation indicates the boundary of the slip surface.

Figure 12. Tensile force of anchor (a)A (b)B (failure of measurement equipment around 2017) (c)No.1 (d)No.4 (e)No.2 (f) No.3.

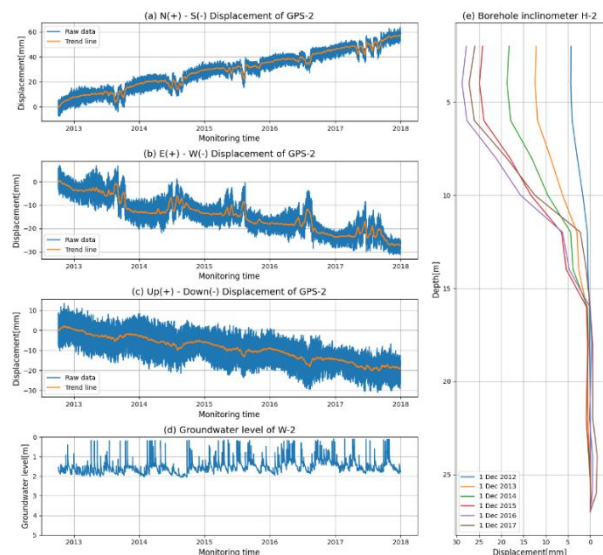
Observation results for GPS-2 displacement next to the upper water collection well and water level gauge W-2 (Fig. 4) are presented in Fig. 13(a)~(c). The slope surface near GPS-2 was observed to continue sliding in the road direction. The displacement trend remained consistent and unaffected by the groundwater level (Fig. 13(d)). In Fig. 13(e), changes in borehole inclinometer H-2 observations from 2012 to 2017 are summarized. A continuous increase in displacement was observed from 16m below the surface, which is believed to be the slip surface depth.

Figure 13. Monitoring results from 2012 to 2017 of (a)~(c)GPS-2, (d)W-2, (e) H-2

determined to be the culmination of the slip surface extending across the entire slope. Based on the extent of deformation observed and the presence of only one slip surface in the H-2 borehole inclinometer (Fig. 13(e)), it was inferred that the head and sides of the overall slip were shared with the upper slip.

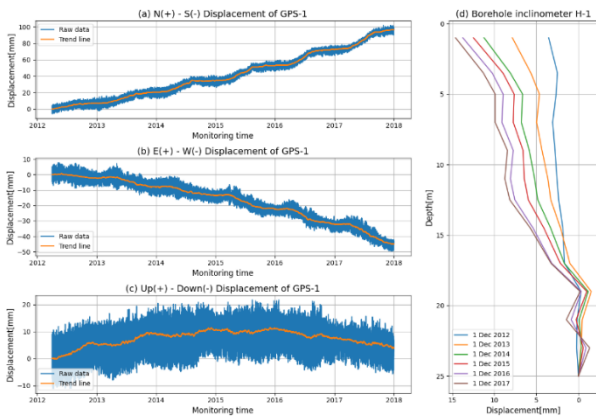
Fig. 14 summarizes the observations of GPS-1 displacement near the center of the slope surface in (a) to (c), as well as the changes in the borehole inclinometer H-1 observations from 2012 to 2017 in (d). From (a) to (c), a gradual progression of displacement was observed from 2012 to 2017. The vertical displacement of GPS-1 shows that it initially rose until around 2015 and then began to sink around 2016 (Fig. 14(c)). This suggests that GPS-1 was located near the end of the upper slip and initially rose due to the predominant upper slip's pushing phenomenon, but then settled due to the development of the overall slip. From (d), it is evident that the upper soil mass continuously slid from around 19m below the surface.

Figure 14. Monitoring results from 2012 to 2017 of (a)~(c)GPS-1, (d)H-1

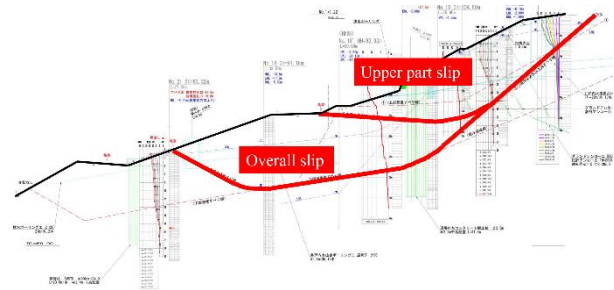
Figure 15. Cross-section view of the slips (Line 1)

Fig. 15 and Fig. 16 show longitudinal sections prepared for the two measuring lines. These maps were created by considering the observations from fieldwork conducted during construction, in addition to the observations described in section 3.1. Unfortunately, no post-service borehole investigations were conducted for the upper and overall slip, and only a few borehole inclinometers were available. Therefore, it is challenging to determine the precise depth of the slip surface for all the sliding blocks. However, due to the landslide being dominated by soft rocks like mudstone and the progressive failure that occurred primordially, the assumed slip surface was set based on the assumption that the ground displacement during construction has occurred since the beginning.

After analyzing the slip surface, soil pressures mobilized by existing countermeasures and the required performance to stabilize slips were calculated. While the current countermeasures met the performance standards in line 1, they fell short in line 2. On this basis, additional ground anchors and steel pipe piles were constructed in 2019 as countermeasures for the upper and overall slips,

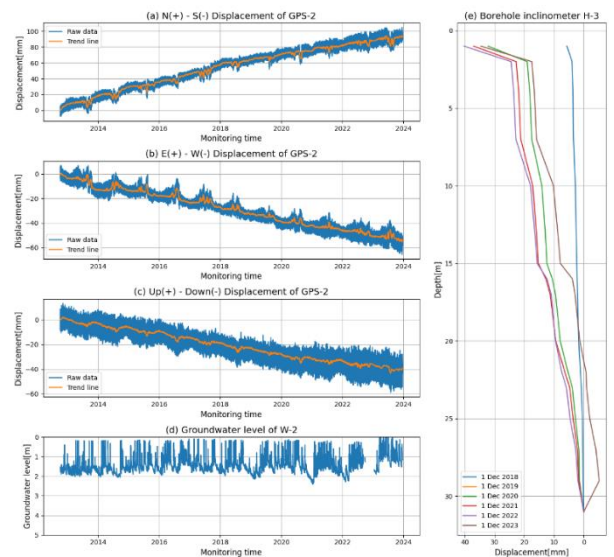
Figure 17. Monitoring results from 2012 to 2023 of (a)~(c)GPS-2, (d)W-2, (e)H-3

The observations from (a) to (c) indicate that surface displacement persisted despite implementing countermeasures. Furthermore, (d) shows that the groundwater level remained high throughout the monitoring period. Notably, a significant displacement occurred near the surface in (e), likely caused by the movement of the upper slip end. Additionally, Fig. 18 demonstrates that there was no change from the upward trend of the anchor load.

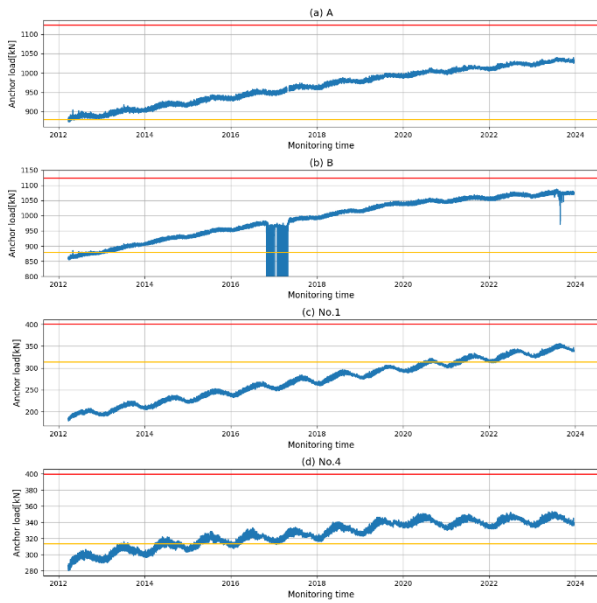
Figure 18. Tensile force of Anchor (a)A (b)B (failure of measurement equipment around 2017) (c)No.1 (d)No.4

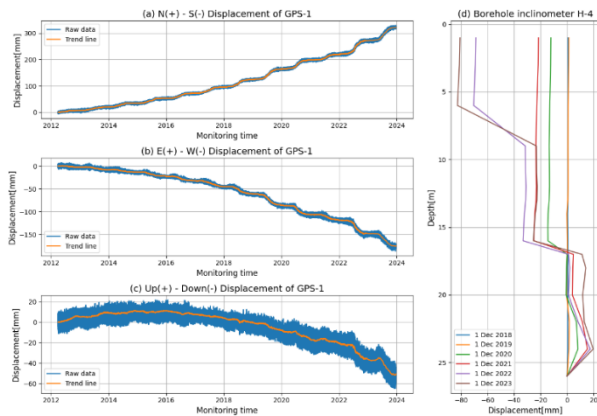
Fig. 19(a)~(c) displays the GPS-1 displacement meter observations from 2012 to 2023, indicating the occurrence of displacement even after countermeasure construction. Fig. 17(e) further suggests the gradual sliding of the entire soil mass from a deeper position, indicating a slip surface deeper than the maximum depth of H-3. In contrast, borehole tiltmeter H-4's observation results (Fig. 19(d)) reveal the presence of a slip surface at a depth of 17 m from 2018 to 2021, followed by a sudden shift at a depth of 9 m and shallower from 2022. This corresponds to the lower slip described in section 3.3.3.

Figure 19. Monitoring results from 2012 to 2023 of (a)~(c)GPS-1, (d)H-4

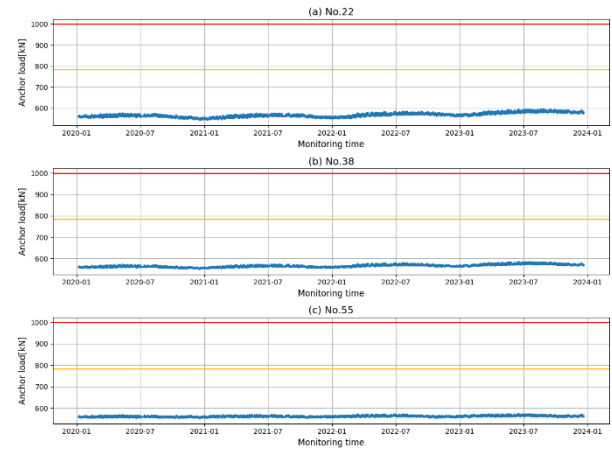
On the other hand, no change was observed in the gauges of the lower steel pipe pile-head anchors installed at the same time as the cut (Fig. 20).

Figure 20. Tensile force of pile-head anchor (a)No.22 (b)No.38 (c)No.55
