## COMPARISON ON METHODOLOGIES AND INTERVENTIONS FOR TWO MASONRY CHURCHES AFFECTED AFTER THE 2017 EARTHQUAKE IN MEXICO

M. ESPONDA<sup>1\*</sup>, AND J. COOKE<sup>2</sup>

**Abstract.** *The current state of two 16th century masonry churches were studied after being damaged during the 2017 earthquake in Mexico. The two complexes being analyzed are part of the World Heritage Site “Ruta de los Conventos”: the Convento de San Guillermo Totolapan, in the state of Morelos south-east of Mexico City, and the Huaquechula Monastery, in the state of Puebla south of Mexico City. These buildings are representative of the architectural model adopted by the first missionaries who evangelized the indigenous populations in the 16th century. The churches were constructed circa 1535 and 1548, respectively. The history and cultural significance for each project is researched in coordination with the stakeholders, along with the contrasting structural systems and any known previous interventions, historic and contemporary.*

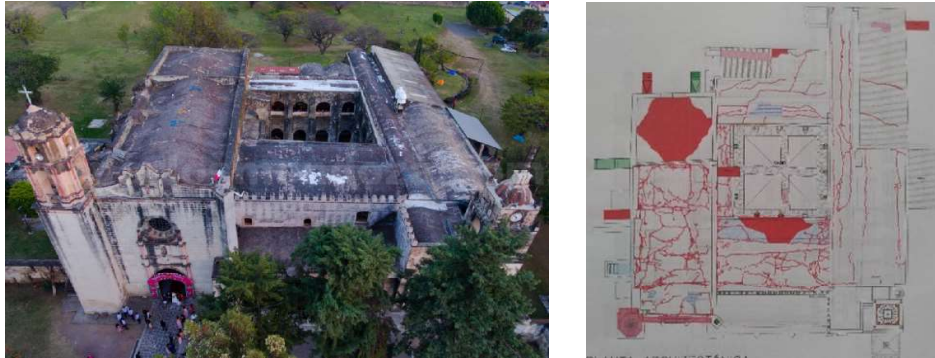
The Totolapan monastery suffered significant damage during the 2017 earthquake. The barrel vaults of the church experienced significant cracking and fracturing. Part of the bell tower collapsed. The pendentive dome completely failed during the earthquake, shearing where the vault is the thinnest. The damage to the cloister includes significant fracturing of the barrel vault roofs, cracking of the walls and failure of many of the buttresses in the courtyard. At the east and west side of the courtyard, the barrel vault roofs had collapsed.

**Figure 1:** Left, before earthquake, Dec 2016 [12]. Right, after earthquake, roof plan showing damages. Red denotes severe damage and fractures. Pink shows missing bell tower. Blue denotes partial collapse of vaults and in green is the detachment and presence of microflora. May 2019 [5].

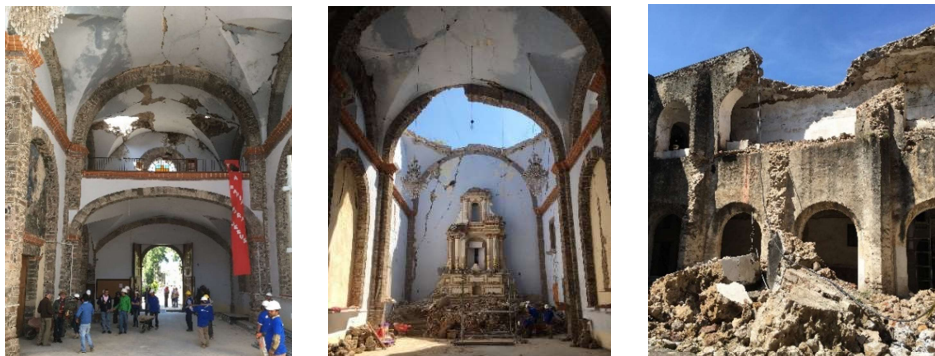
These vaulted roofs surrounding the courtyard were constructed using poor quality adobe mortar and small rounded river stone. The vaults had sustained fractures during previous earthquakes and had been repaired using a cementitious grout, which appears to have magnified the current failures. The vaults were coated in a plaster which has cracked, but there was no evidence of any waterproof coatings over the plaster. From this, it can be concluded that the mortar in the vault had deteriorated prior to the earthquake from continuous exposure to moisture. The presence of moisture results in activation of soluble salts, which then recrystallize, expanding and damaging the existing adobe mortar.

**Figure 2:** Photographed damage 4 weeks after the earthquake, Oct. 2017. **Left:** Fractures and partial collapse of nave vault. **Center:** Complete failure of the apse dome. **Right:** Collapse of vault and buttresses of the cloister.

The walls of the nave had also experienced large fractures, and many of the large buttresses were damaged, some completely collapsed and others fractured full height at the face of the walls. Some of the buttresses at the cloister failed due to bending perpendicular to the wall. There was a general lack of large tie stones to hold the masonry together. The major fractures to the walls were noted mainly where they intersected the exterior walls, or through wall openings. Several infill walls in original arches had also displaced.

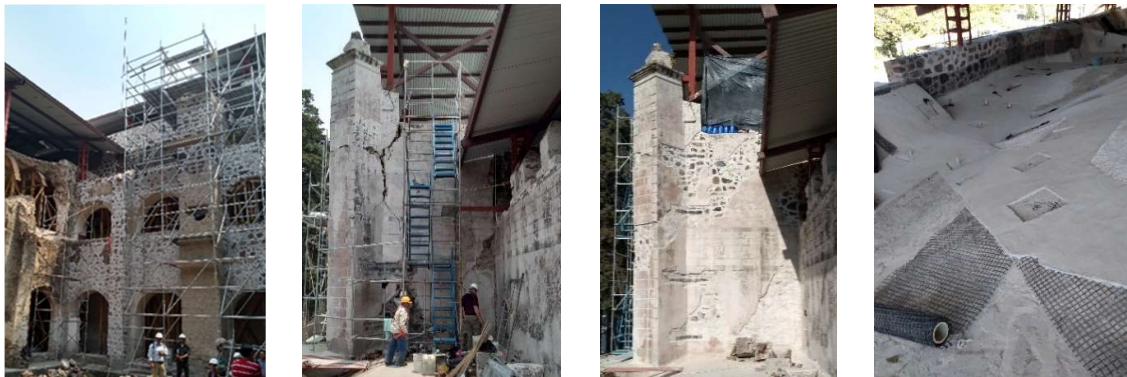
The large bell tower, the stone arch above the entrance that supports the open bells, and some of the crenellations around the roof, fell outwards. The bell tower was constructed such that it was only attached to the main structure at one corner. Once it separated from the nave, it became a tall slender structure, with a different mode of vibration to the main structure.

At the other corner of the monastery there is a smaller masonry bell tower which was also damaged. It appears that the rocking of the tower resulted in hinges forming at the base of the four corner pillars, and in the apex of the arches between the pillars. It was observed that at each of the hinge locations, where the plaster had spalled, dislodged and debonded loose rubble masonry was observed. The staining indicates mould and long-term moisture saturation.

**Figure 3:** Left: Reconstruction and consolidation of walls and buttresses in the courtyard, Dec 2019. Two central images: Bell tower with damages, May 2019, and after repair by integrating horizontal large volcanic stones, Dec 2019. Right: Rehabilitation of the roof vault by adding carbon fibres in a cross pattern, Dec 2019.

Work is proceeding on smaller areas before the more extensive interventions. Most fractured walls of the church are being consolidated, by drilling ports and inserting small copper pipes in the walls. A mix of lime, sand and pozolime grout is injected. The collapsed buttresses are also being rebuilt, using metallic ties to anchor to the walls.

The large fractures in the apse walls are being repaired by first dismantling the masonry on each side of the fracture and removing all debonded material. The wall then is rebuilt across the crack, with compatible mortars and large volcanic stones –basalto- of high density and strength. This is an excellent solution as compatible materials are used to reinforce the masonry at known weak points. Provided that the mortars are compatible with the original adobe mortars, with similar strength and porosity, this will permit vapour transmission from the original to the new masonry and allow the assembly to function as originally intended. This construction also bonds well with the existing masonry, so that they can function as a single unit in future earthquakes. It is critical, as part of the rebuilding, that all dust is removed at the interface between the old and new mortar, otherwise the bond between these two materials will not occur.

They are also introducing tensile strength to the top of the nave barrel vaults by applying carbon fibre to better resist the formation of hinges and therefore seismic forces. The methodology applied in the barrel vault followed the cleaning of the whole area, drilling ports and injecting traditional mortar into the fractures, and applying the carbon fibre in a cross “X” pattern which is anchored to the barrel vault slab. This is a new methodology that has just been initiated in rehabilitation projects in L’Aquila, Italy after the 2009 earthquake. It will be important to monitor this new intervention for its compatibility with the 500-year-old structure.

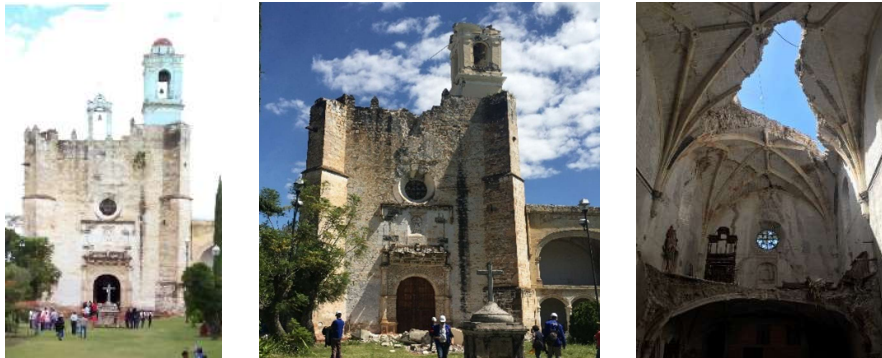
The Huaquechula Monastery experienced significant damage during the 2017 earthquake. The upper portion of the bell tower collapsed and fell through the first ribbed vault roof of the nave. The main facade has a large central entrance door under an ornate rose window. These openings substantially weakened the wall, resulting in a large vertical shear fracture. The masonry arch that supports the bells above the entrance collapsed. The adjacent convent experienced minor damage to the barrel vaults, and to some of the interior dividing walls.

**Figure 4:** **Left:** Before the earthquake, May 2017 [13]. **Center:** After the earthquake, Oct 2017. **Right:** Damage sustained by the ribbed vault caused by the collapse of the top part of the bell tower, Oct 2017.

The bell tower failed at mid-height, collapsing into the nave during the earthquake. It is important to highlight the entire section which had been reinforced with concrete and steel in 1999 had collapsed. The steel angles were still on site in May 2019, and except for minor bending, the entire structure was intact. This indicates that the tower failed under rocking motion, with hinges forming below the steel frame. Damage from the formation of hinges was evident at the base of the lower portion of the tower. The joints in the masonry at the location of the hinges were in poor condition, indicating that they had not been recently repointed.

The extents of the large hole through which the tower had fallen, clearly show the effectiveness of the ribs at reinforcing the roof structure. Only the ribs immediately impacted

by the tower failed. Adjacent ribs confined the collapse to the area of the impact only. It can be observed that this rib pattern increased the depth of the vault, giving it a greater capacity than the Totolapan Monastery, and also introduced more redundancy into the design, allowing part of the vault to remain intact despite the collapse of the tower.

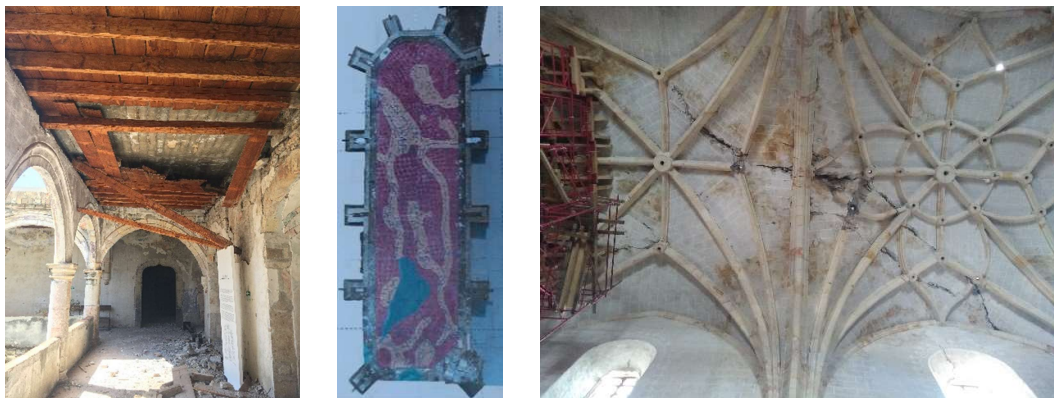
The remaining roof vaults which were not damaged by the tower still exhibited recurring cracking and spalling. The side walls of the nave were subjected to out of plane forces and would have displaced in out of plane bending. The cracking is more significant at the apse which, due to the semi-circular floor plan and large number of exterior buttresses, had created a stiff point resisting the movement of the rest of the roof. The wall on the north side of the nave is stiffened by large buttresses, but the south wall is connected to the two-storey cloister that increases the stiffness of this wall, with additional cross walls/buttresses. The two walls of the nave have different fundamental periods and resonance frequencies, resulting in differential movement. At some time during the earthquake, the tops of the walls moved apart, creating a geometric imbalance and caused cracking in the vaulted roof parallel to the side walls.

**Figure 5:** **Left:** Damage caused by reinforced concrete roof in the cloister, Oct. 2017. **Central:** Proposed intervention to the nave. Blue indicates reconstruction with similar material. Yellow indicates consolidation at the crack locations. Red only requires a waterproof coating using traditional methods. [14] **Right:** Main fractures to ribbed vault, May 2019.

The roof of the adjacent convent was originally of heavy timber construction, with plank decking. This type of construction is flexible, and absorbs energy. After the 1999 earthquake the wood was removed and replaced with reinforced concrete slabs. This is an inappropriate intervention since it is now an extremely stiff element which distributes the energy to the adjacent walls. The impact of the added stiffness during the earthquake was immediately apparent. First, where the slab abutted the wall of the church, the slab pounded into the masonry, resulting in localized masonry failure. Second, these slabs have a significant impact on the natural frequency of the adjacent monastery and therefore the south wall of the nave, likely causing greater damage to the roof of the nave. The reinforced concrete slabs remained intact, with no cracking noted. In some areas the large arched openings of the convent were infilled with stone masonry. The infill masonry had separated during the earthquake. This damage is due to a poor construction detail, where the interior wall was constructed after the exterior wall, with no key stones installed across the construction joint.

The ribbed vault roof of the Open Chapel appears to have a number of fractures with a similar pattern as the fractures following the 1999 earthquake. There is evidence of previous repairs at these hinges, by filling the cracks with, possibly, cementitious grout. The repair failed during this earthquake, causing the cracks to reopen. This highlights the need to rebuild across cracks with solid material, as simple infilling leaves the previous failure as a weak point, and does not allow the assembly to act as a singular unit.
