In-situ cyclic direct shear tests on volcanic soil in the site of landslide due to earthquake

Keywords: cyclic direct shear test, In-situ testing, volcanic pumice soils

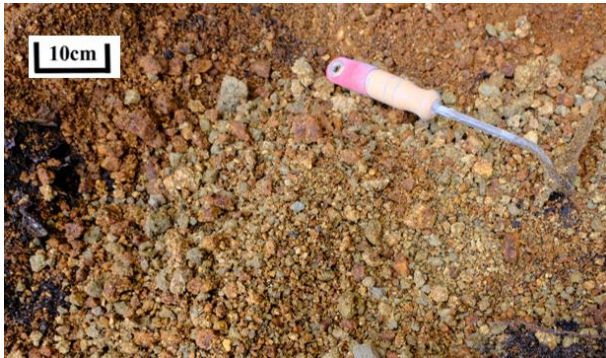
Fig. 4 shows reddish-brown pumice soil exposed in the investigated area. Based on its characteristics and the surrounding sedimentary layers, this pumice soil is Tarumae d (Ta-d), which was deposited approximately 9,000 years ago among the volcanic pyroclastic flow deposits of Tarumae Volcano. The Ta-d layer is considered to play a significant role in the slope failure caused by the earthquake. The Ta-d layer was thicker in the area where the slope failure occurred compared to the area where it did not occur (Kawamura et al. 2019).

Figure 4. Ta-d pumice

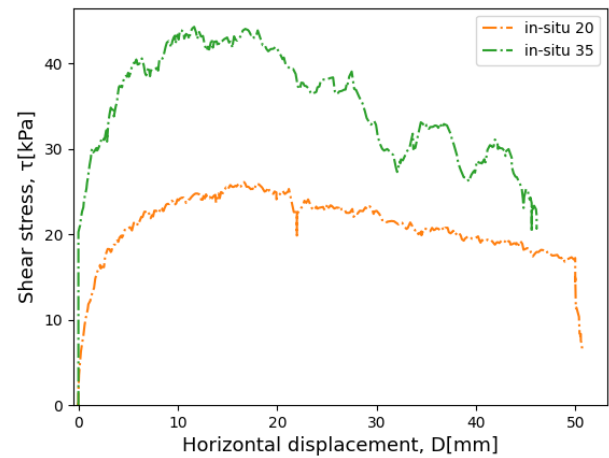
Fig. 5 shows the relationship between shear stress (τ) and horizontal displacement (D) from in-situ direct shear tests. Peak strength was reached at around 13 mm. After reaching the peak, shear stress decreased in response to displacement but did not reach a full residual state, probably because the amount of displacement was not sufficient.

Figure 5. Results of in-situ direct shear tests

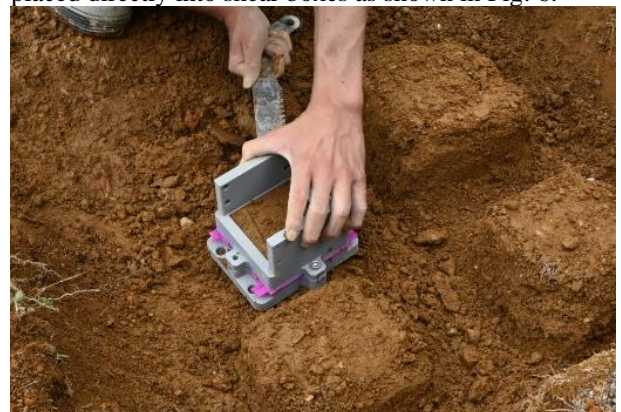
Direct shear tests were conducted on Ta-d under constant pressure conditions using a conventional direct shear test apparatus in laboratory. The specimens used were 80 mm square and 65 mm high. Tests were conducted on three intact specimens and three reconstructed specimens, as presented in Table 3. The intact specimens were transported with minimal soil disturbance by fitting them into a shear box created by a 3D printer. Intact specimens were trimmed on site and placed directly into shear boxes as shown in Fig. 6.

Figure 6. Field sampling of intact specimens

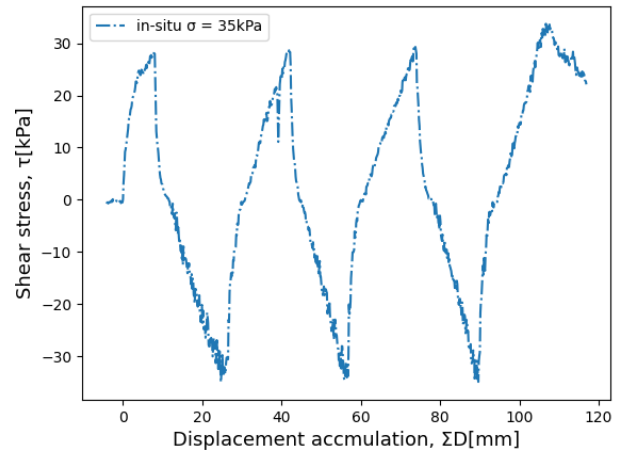
Fig. 9 illustrates the correlation between shear stress (τ) and cumulative horizontal displacement (ΣD) obtained from in-situ cyclic direct shear tests. Similar to the ordinal direct shear test, minor oscillations are visible due to the nature of the jacking. The strength at turning point ($\Delta D = 7$ mm, $P_d = 5.83\%$) decreased slightly with an increasing number of cycles, which is believed to be due to approaching the residual strength.

Figure 9. Results of in-situ cyclic direct shear tests

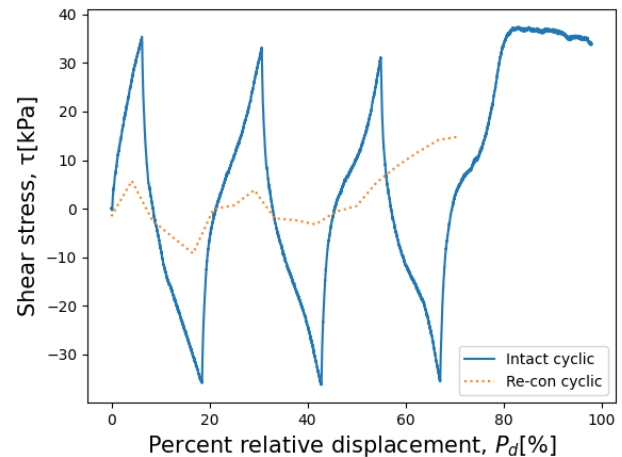
Fig. 10 illustrates the relation between shear stress (τ) and cumulative horizontal displacement (ΣD) obtained from laboratory cyclic direct shear tests.

Figure 10. Results of laboratory cyclic direct shear tests

The shear strength at the fold point ($\Delta D = 4.7$ mm, $P_d = 5.8\%$) of both re-con and intact specimens decreases with the number of repetitions. As with the monotonic direct shear test, the shear strength of the intact specimens was found to be higher than that of the reconstructed specimens.

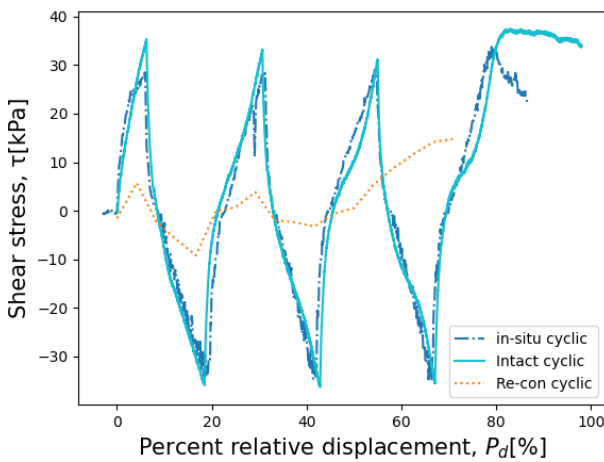
Fig. 11 shows the relationship between relative displacement and shear stress. For clarity, the intact line has been changed to a lighter colour; the intact and in-situ shear stresses were almost identical, with the re-con having significantly lower strength. Behaviour of intact and in-situ tests are almost the same, indicating the soil structure retained for both cases.

Figure 11. Relationship between shear stress and percent relative displacement

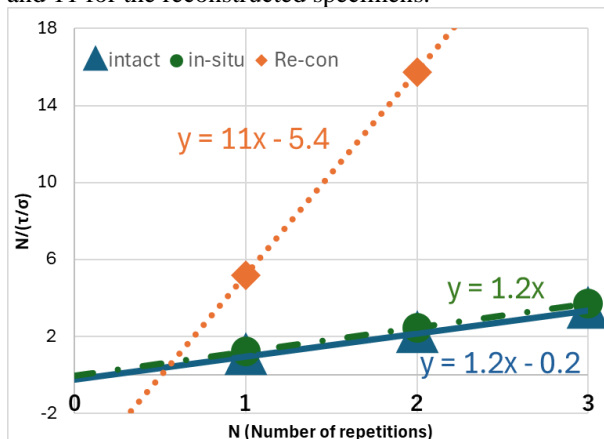
Fig. 12 shows the relationship between $N/(\tau/\sigma N)$ and N (number of repetitions) for fitting the measured values from the in-situ and laboratory tests to Eq. 1. The slope of the straight line, determined using the least-squares method, corresponds to b in Eq. 1. The strong correlation between the measured values and Eq. 1, demonstrated by their linear relationship in all tests, suggests that Eq. 2 is a suitable model to use. The coefficient b was found to be 1.2 for the in-situ tests, 1.2 for the intact specimens, and 11 for the reconstructed specimens.

Figure 12. Relationship between $N/(\tau/\sigma N)$ and N

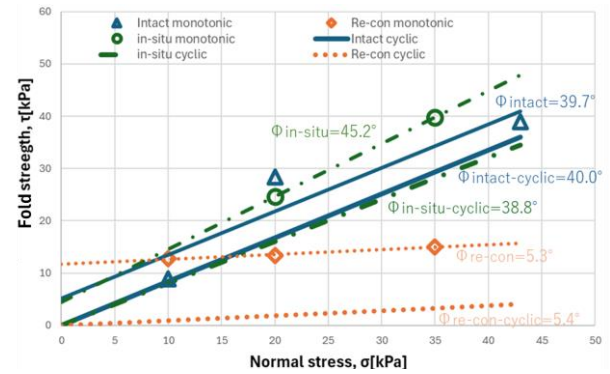
Fig. 13 illustrates the fold shear stress (τ_{fold}) obtained from the direct shear test plotted against the normal stress (σ), along with the relationship between fold strength and normal stress obtained from cyclic direct shear tests and Eq. 2. The relationship between fold strength and normal stress obtained from cyclic direct shear tests is added in Fig. 8. The shear resistance angles for the in-situ and intact tests were found to be almost the same, at 38.8° and 40.0° respectively. However, the reconstructed specimen had a very small shear resistance angle of 5.4° . The shear resistance angles were similar for all specimens when comparing the monotonic and cyclic direct shear tests.

Figure 13. Residual shear strength for in-situ and laboratory cyclic direct shear tests
