# BRITISH COLONIAL ERA'S RELIGIOUS BUILT HERITAGE IN YORUBALAND, NIGERIA: KEY CONSERVATION PROBLEMATICS AND THE STATE OF KNOW-HOW

REYHAN SABRI<sup>1\*</sup> AND OLUSEYI A. OLAGOKE<sup>2</sup>

**Keywords:** Religious Built Heritage, Conservation Problematics, Spatial Requirements, Modification of Original Fabric, Adaptive Reuse

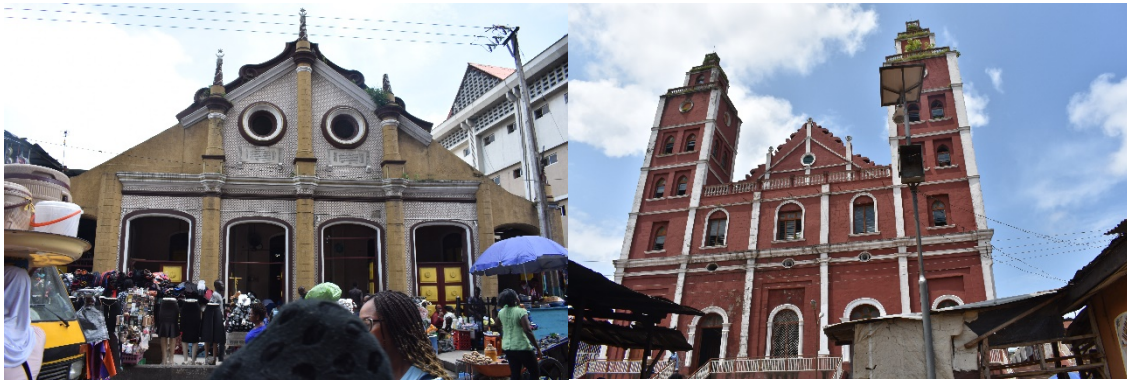
These Afro-Brazilian style mosques introduced the first monumental scale mosques in Yorubaland. The earliest ones were erected in Lagos, in the late 19<sup>th</sup> century, and they set the architectural vocabulary for several chief congregational mosques in Yoruba cities, with most surviving examples from the 1930s and 1940s in various Yoruba towns. The oldest surviving mosque structure is the Shitta Bey Mosque in Lagos, built in 1891-94 [5]. This architectural language included a pedimented central structure, with single or double minaret-towers situated on the front or rear façade; in both cases having the similar longitudinal plan layout. The details and ornaments changes drastically depending on the repertoire of the master-builders, including: pediment crowned with scrolls, round or elliptical oculi and arched openings with stucco surrounds, stringcourse that extends horizontally on the façades, engaged columns, pilasters and plinths, and various stucco decorations, emphasized quoins, rectangular windows topped with decorated blind arches or floral motifs, ornate balustrades surmounting the minaret-towers and roof lines, and Baroque style dormers on the roof level of the side facades (Figure 2).

Figure 2: Shitta Bey Mosque in Lagos (left), and Central Mosque in Abeokuta (right)

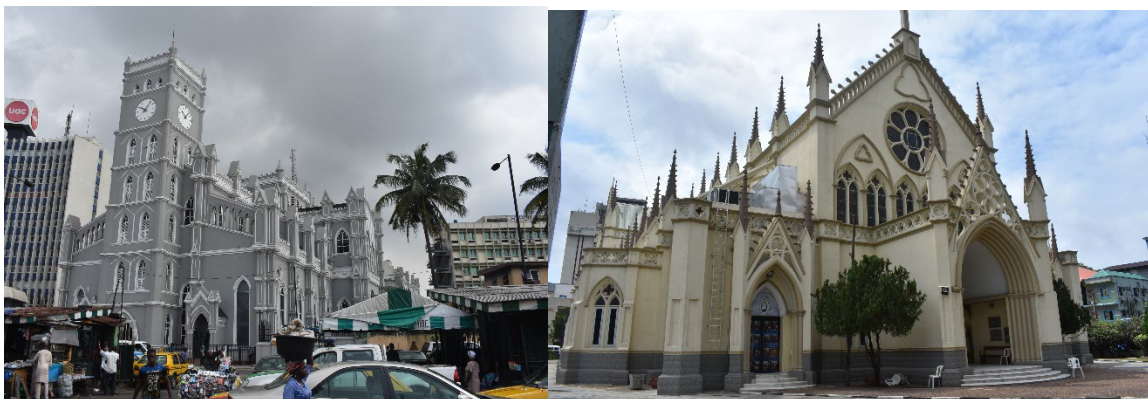
The emergence of church structures in Yorubaland started with the establishment of the first formal church, St Peter's Church in Ake, Abeokuta in 1847 <sup>[14]</sup>. While the early churches in Yorubaland were erected under the directives of the missionaries, these were mainly mud-and-thatch structures which did not survive. Similarly to mosques, churches with durable materials, mainly brick, stone and metal roofing sheets, started to emerge in the last quarter of the 19<sup>th</sup> century. The 20<sup>th</sup> century witnessed the reconstruction of these structures in larger scales to accommodate their growing congregations. The oldest surviving church building is the St. Peter's Church in Ake, built during 1898-1900. While initially the hall-type dominated, from the 1910s until the end of the colonial era, churches were designed mostly in Basilica layout. Neo-Gothic style, both in European versions and in simplified-localised versions, dominated the morphology and aesthetics of the churches from the late 19<sup>th</sup> century, including: pointed arches, lancet windows with Gothic style mullions, oculi, archivolts, stringcourses, nave arcades with compound piers supporting pointed arches (Figure 3).

Figure 3: Christ Church Cathedral (left), and Holy Cross Church Cathedral (right) in Lagos

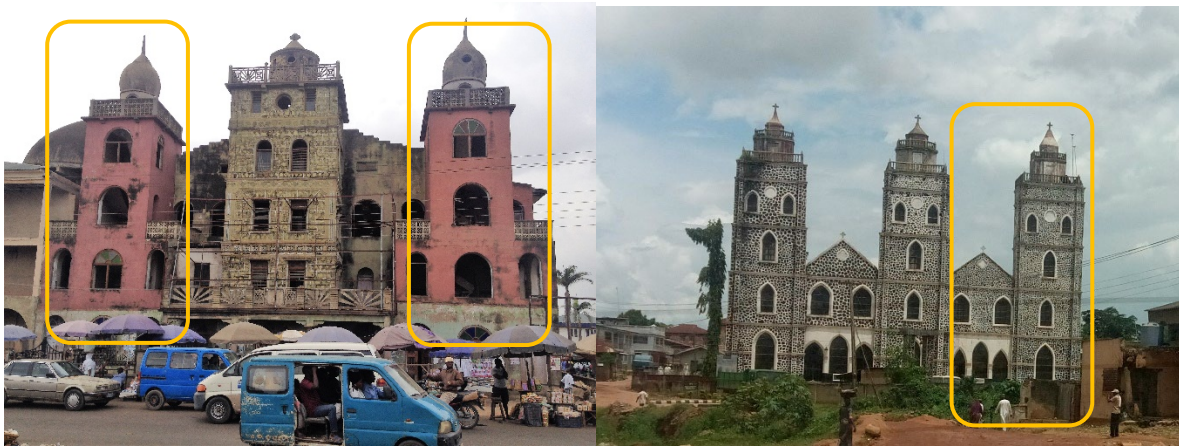
Among the most radical modifications are the addition of towers in addition to congregation and administrative spaces. For the mosques, a case in point is the Central Mosque of Osogbo, where two new minaret-towers were added to the existing tower and single hall layout mosque in ongoing extension work started c.1995. The new square minaret-towers are similar to the original tower (Figure 5). However, a massive dome was installed as an afterthought to the expanded section which does not suit the building. The facades of the original mosque have been obliterated as the building was expanded. Overall, the expansion is too massive and the morphology of the new additions cause confusion rather than harmonious integration. In a similar vein, a new hall and a bell-tower was added to the originally two-bell-towered Holy Trinity Church in Abeokuta, replicating the existing ones, and making it difficult to differentiate the newly added parts from the originally existing ones (Figure 5).

**Figure 5:** Modifications on Central Mosque in Osogbo (left), and Holy Trinity Church in Abeokuta (right)

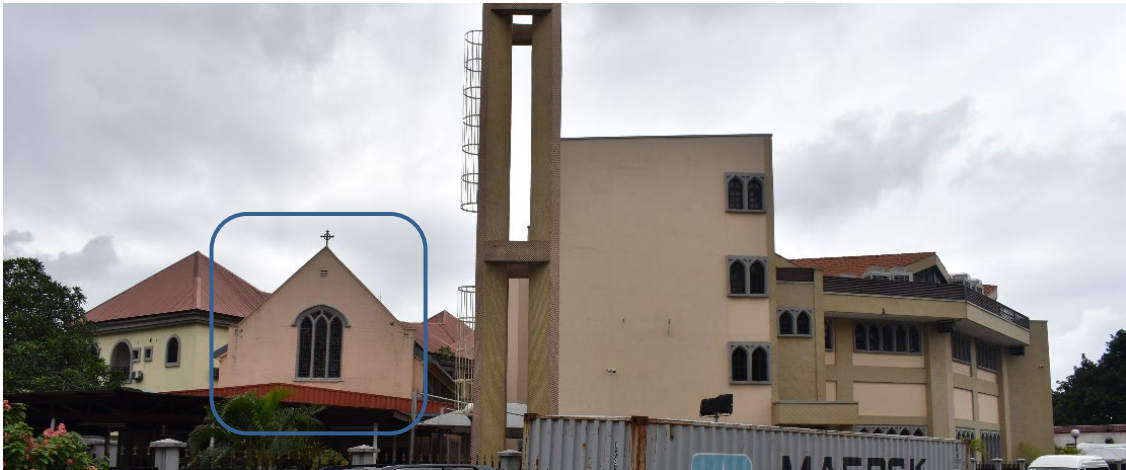
In a different approach, when more space was needed for congregations at the Our Saviour's Church in Lagos and a new structure was built surrounding the old one, the latter remained in use in its original function (as a supplementary church space). However, while the facades of the new structures replicate the windows of those at the old church, creating a somehow successful harmony, the scale of the new structures are massive, dwarfing the old building (Figure 6).

**Figure 6:** Our Saviour's Church (Lagos), cramped in recently constructed new church buildings
