# Using combined geotechnical and geophysical methods for site characterization of ultra-shallow submerged sites

Nina Stark<sup>1#</sup>, Michael Gardner<sup>2</sup>, Anne Lemnitzer<sup>3</sup>

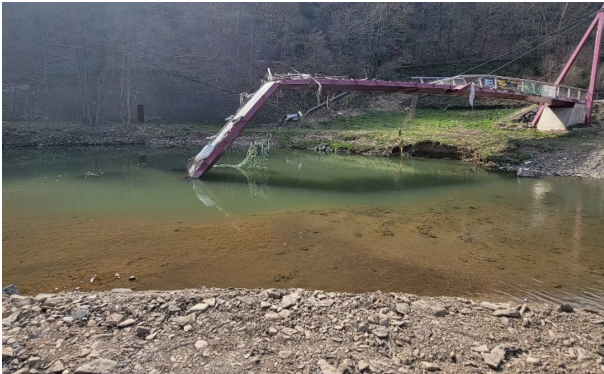
**Figure 1.** Pink pedestrian bridge in Mayschoss, Germany after the July 2021 western European flood event.

At the time of the survey, the bridge was severely damaged but still in place as shown in Fig. 1. One of the bridge abutments was washed away by the flood, while the other one was damaged but still standing and the bridge deck was hanging into the river. The damaged bridge was removed about 9 months after the flood event, but it was still in place in the state shown in Fig. 1 during the measurements. Other than stabilization of the fringing street, no alterations had been made to the area between the flood and the measurements. High-water marks suggested that flood waters reached well above the bridge

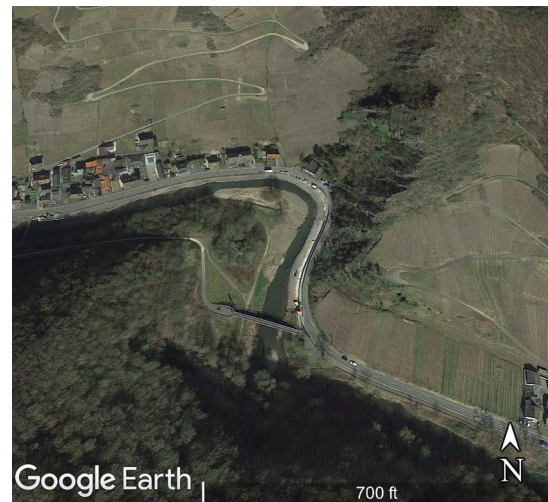
**Figure 2.** Google Earth image from March 2020 (prior to flood) showing bridge and river bends.

The bridge crossed the Ahr river approximately 100m downstream of a <math><90^\circ</math> right bend of the river and just in front of an approximately <math>90^\circ</math> left bend of the river (Fig. 2). The riverbank is fringed by an asphalted road on the northern bank and by steep rock walls and a shoal in the right bend on the southern riverbank. The terrain is overall steep with little flood plains. The riverbed in this section is mostly composed of gravel and cobbles, and the mean water depth is well under 1m.

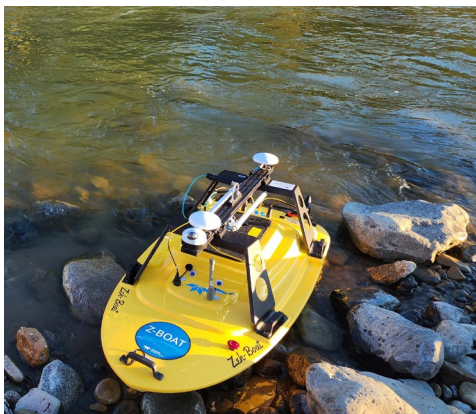
Figure 3. Photo of the Z-boat.

A dual-frequency single-beam sonar deployed from a *Teledyne Marine Z-boat 1800* (Fig. 3) was used to measure bathymetry. The Z-boat was remotely operated by staff of the RAPID-NHERI reconnaissance facility, University of Washington. Bathymetric mapping was performed using the commercial software package *Hypack* also by RAPID-NHERI staff members. The Z-boat was able to operate at water depths > 0.3 m and deeper and was remotely controlled but accompanied by a support person nearby and with the ability to access the water due to the possible hazard of debris under the water surface.

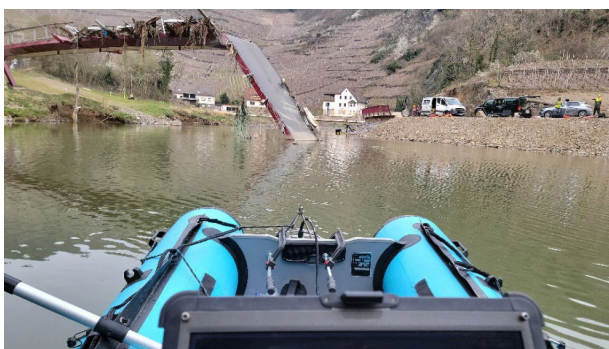
Figure 4. Side scan sonar arrangement. The sonar is hanging off the stern of the inflatable vessel.

A *Kongsberg Mesotech MS-1000* rotary side scan sonar was deployed to image the riverbed to investigate the presence of debris as well as the contact of the hanging bridge deck with the riverbed. While the rotary side scan sonar is typically deployed using a tripod that is placed on the seabed. The risk of unknown bathymetry and debris led to the decision to deploy the side scan sonar from an inflatable vessel kept stationary through guidance of a rope that was installed from one riverbank to the other or by landing the vessel at the riverbank (Fig. 4). Side scan sonar is creating an image of the riverbed from acoustic backscatter of a transmitted and received

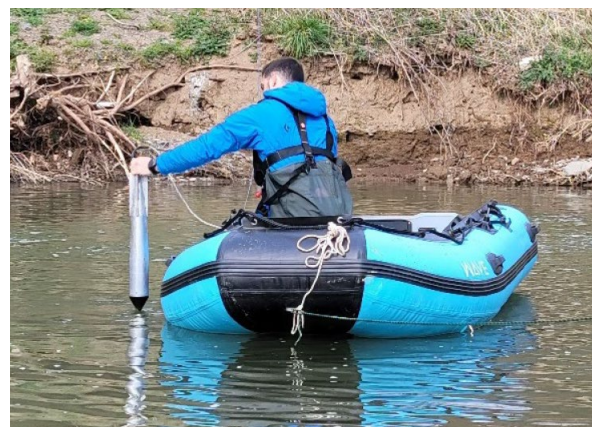
Figure 5. Portable free fall penetrometer measurements.

Portable free fall penetrometer (PFFP) measurements using the *BlueDrop* were conducted from an inflatable vessel (Fig. 5) in all locations that did not feature an obvious cobbly riverbed or debris based on the side scan sonar image and visual inspection. The probe was deployed and retrieved by hand. The deployment strategy followed conceptually work by Jaber et al. (2021). The PFFP measures deceleration and ambient pressure behind the nose cone, allowing to derive information about sediment type, layering, and geotechnical engineering properties over the penetration depth. The penetration depth is limited to typically around 0.1-0.2m in coarse-grained sediments and < 1m in fine-grained sediments. The rugged design allows for unplanned impacts with cobbles, but such data are not informative beyond the information that the probe impacted with a rock.

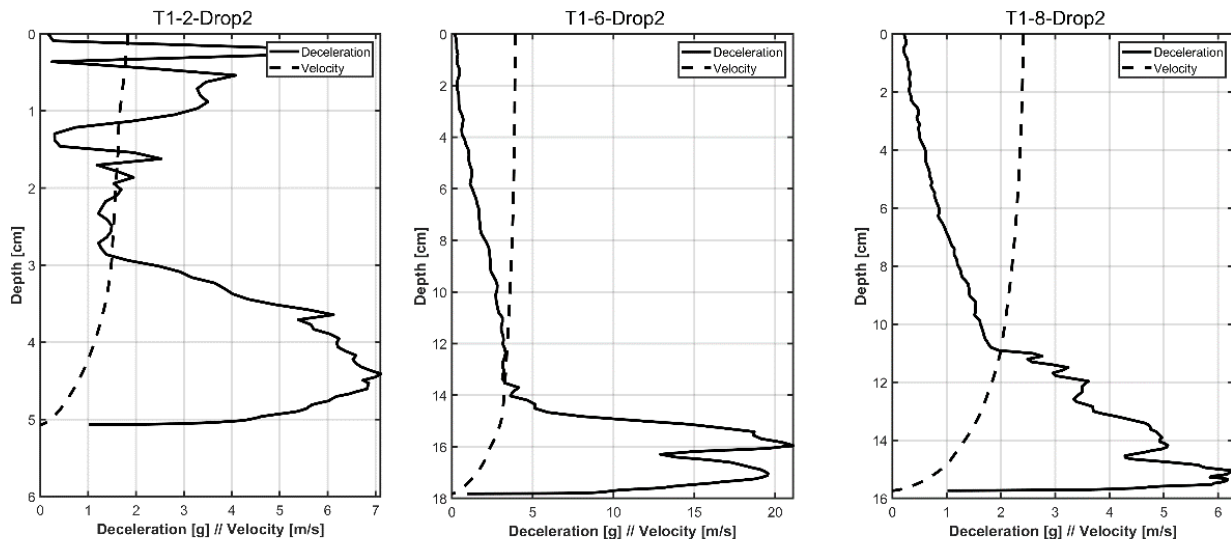
**Figure 10.** Three examples of portable free fall penetrometer profiles recorded along the area of the fine-grained sediment deposits on the inner bend shoal. The profiles show the measured deceleration of the probe after impacting the riverbed and the derived velocity (from single integration of deceleration) against penetration depth.

deposits on the inner bend shoal. Figure 10 shows three example results. Fig. 10 (left) suggests the presence of gravel at the surface but still a soft and fine-grained sediment layer of  $\sim 3\text{ cm}$ . Moving further onto the shoal (Fig. 10 center and right), a clearly distinguishable fine-grained and soft sediment layer is profiled with a thickness of 10-14 cm above gravelly and coarser-grained substratum. Considering the spatial extent of the shoal, it suggests a significant volume of unconsolidated fine-grained flood deposits.
