When did geotechnical data become a point of view: a case of numerical analysis vs site data

ABSTRACT

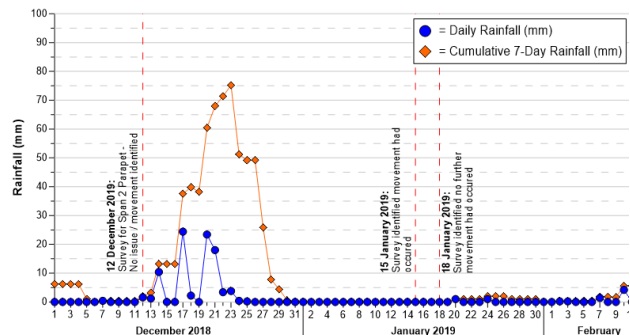
Figure 4. Rainfall data – daily (blue) and cumulative 7-day rainfall totals (orange)

Rainfall data sourced from the nearest publicly available weather monitoring station (Figure 4) shows a period of significant rainfall occurred within the period that site movement is inferred to have commenced. No survey observations were taken for the Xmas period, although pile removal was carried out.

The rainfall is not considered extreme but is associated with a high tide of 2.04m which occurred at the same time and has a 1.1% probability based on 1095 days of record i.e., 12 events over that period.

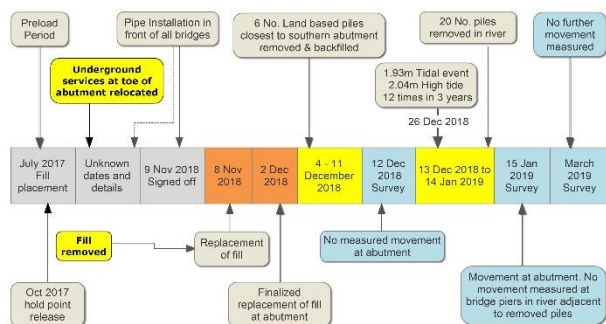
Figure 5. Time history after the fill period, its removal and reinstatement and dates of survey

Figure 5 summarizes the historical events. The survey on 12 December 2018 showed no movement after the removal and back filling of the 6 land-based temporary piles closest to the bridge abutment which occurred over an 8-day period. The removed piles between 10 December and 10 January 2019, when movement was first observed, was 9m to 75m distance from the temporary abutment. A few of those water-based piles were closer to the permanent bridge piers than those removed near the abutment. The survey did not show similar movements adjacent to those river piles.

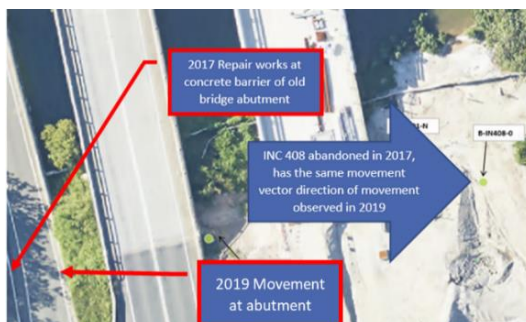
Figure 6. Repair works undertaken

The review of the historical data shows that the heritage bridge had commenced movement in January 2014 (earliest available photo records) with 2017 repair works. In 2019 another (new?) movement at that heritage bridge abutment is evident (Figures 6 and 7).

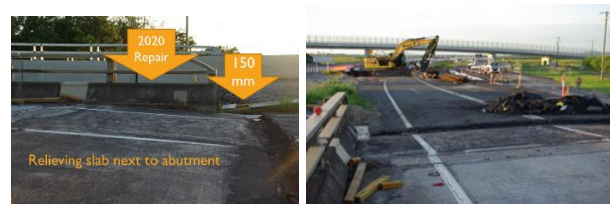
Figure 8. 2020 releveling of 1991 adjacent bridge with 150mm drop in the relieving slab

The adjacent 1991 bridge underwent releveling in 2014 based on historical Google photos and again in 2020 at the southern abutment (Figure 8). These photos show the ongoing history of settlement at the adjacent south bound bridge abutment.

Thus all 3 bridges needed some repair at the southern abutment although the subject was the new bridge.

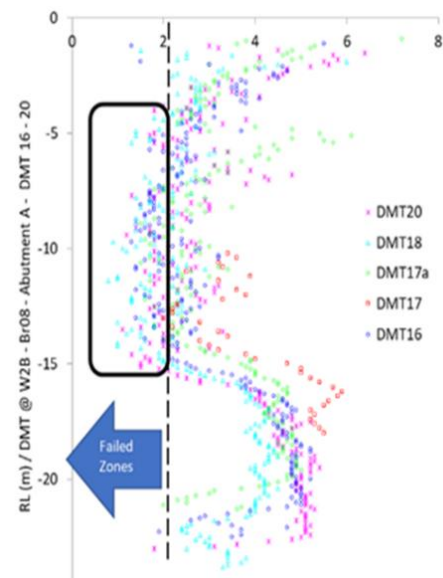
Figure 11. Low K_D values by DMT location.

All 10 DMTs showed shear zones at depth irrespective of proximity to the temporary piles (Figure 11). These results suggest dormant slip surface extends

to the base of the sensitive clays (\sim RL-14) identified in the 2016 and the 2019 CPTs and the inclinometers.

If one accepts that a low K_D result is a failed zone, then by extension all the DMTs are in a failed zone whether the test is close or far from the abutment. Potential dormant slip planes occur even 30 – 35m away from the bridge abutment. The DMTs were also used to compare strength profiles

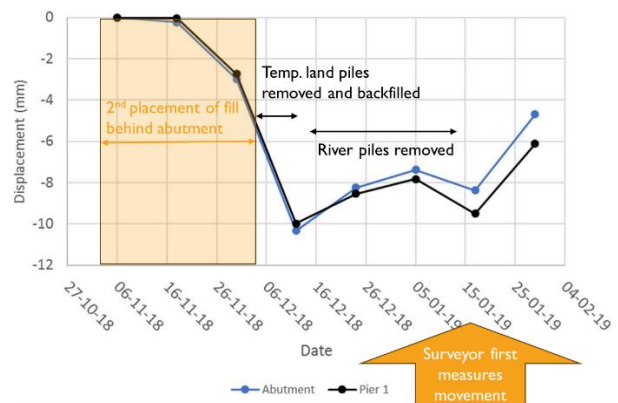
Figure 13. INSAR data at two points on bridge

Interferometric synthetic aperture radar (INSAR) data was obtained. The satellite passes every 2 weeks at this location and shows movement starting during the fill placement (Figure 13) and before removal of the temporary piles. This line-of-sight measurement is at the top of bridge deck and at road level while the surveyor measured lateral movement below the bridge deck. Thus, movement magnitude was not expected to coincide.

This data was obtained 9 months after all other data were available. Note on 12 December, the surveyor had not reported any movement.

The timing of these final layers being placed matched the start of movement as noted by INSAR satellite line of sight measurements analysis. The factor of safety reduced by 0.02 to 0.11 depending on the type of model analysis when the actual fill pressure is used.

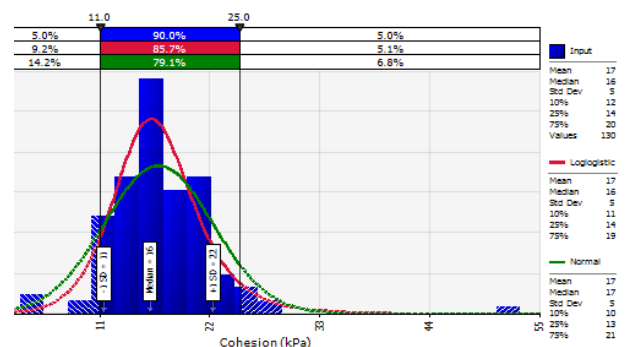
Figure 14. Undrained cohesion between piles

The 20 CPTs and 10 DMTs provided a significant local data at this abutment area, and which was not previously available. Figure 14 shows the spread of results and best fit and normal probability density functions (PDF) from 130 DMT results for the undrained

cohesion between the temporary piles. A median cohesion of 17 kPa was used in the short-term analysis and the soil variability included for a probability analysis. These results and others for the interbedded layer were presented in Table 1

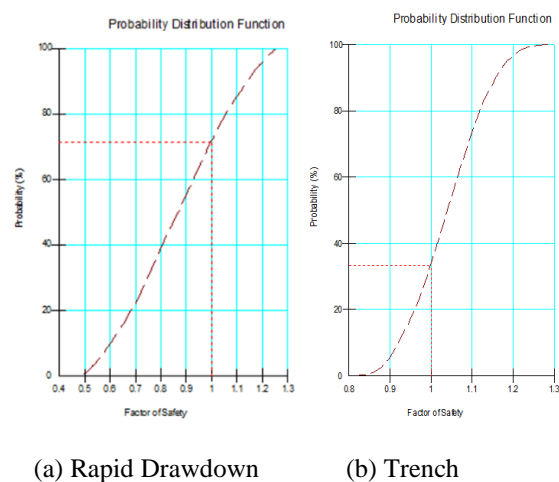
Figure 15. Probability of failure if (a) rapid drawdown or (b) trench is used in analysis

Figure 15 shows the probability of failure for the case of a rapid drawdown and service trench in front of the embankment using this new and extensive soite data. There is a 33.3% and 71.4% probability of failure for the former and latter, respectively
