Durability in Marine Environment of High-performance Concrete with Electric arc Furnace Slags and Cupola Slag Admixture

Israel Sosa, Carlos Thomas, Juan Antonio Polanco, Jesús Setién and Pablo Tamayo

LADICIM (Laboratory of Materials Science and Engineering), University of Cantabria. E.T.S. de Ingenieros de Caminos, Canales y Puertos, Av.Los Castros 44, 39005 - Santander, Spain.
ladicim@unican.es

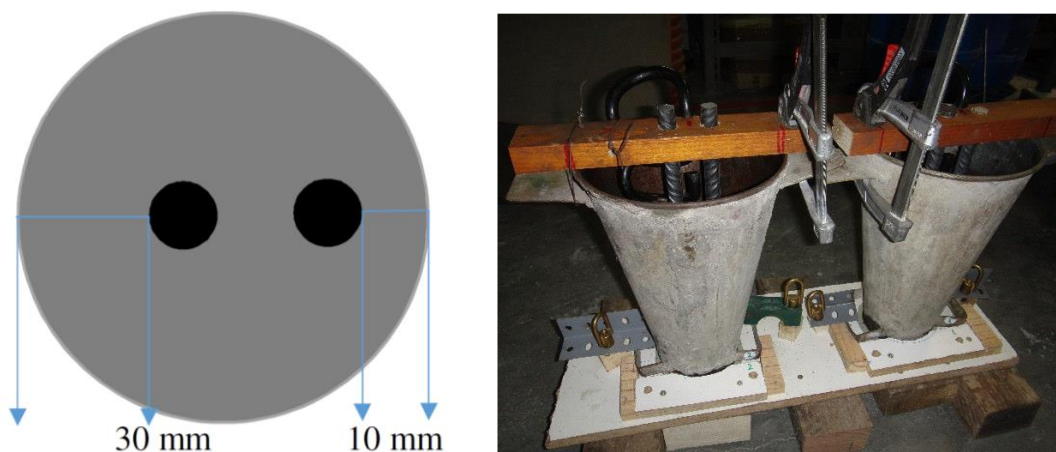
The test campaign for the characterization of the durability of hardened concrete consists of exposure to seawater of conical specimens with embedded corrugated steel bars. For the manufacture of each specimen, an Abrams cone with the face of smaller diameter as a base, has been used to facilitate filling of the specimen, following the methodology described by C. Thomas *et al.* (Thomas *et al.*, 2013). In its interior two corrugated bars of diameter 10 mm have been placed vertically, arranged in such a way that the minimum covering of one of the bars at the base of the cone is 10 mm while, in the second bar, it is 30 mm, Figure 1.

Figure 1. Arrangement of reinforcement bars on the underside of the cone and preparation of the truncated conical molds.

In Figure 1 can be seen that, in addition to the corrugated bars, a black metal part has been embedded in order to facilitate the manipulation of the specimens, avoiding any kind of effort in the steel that can affect the adhesion between both materials.

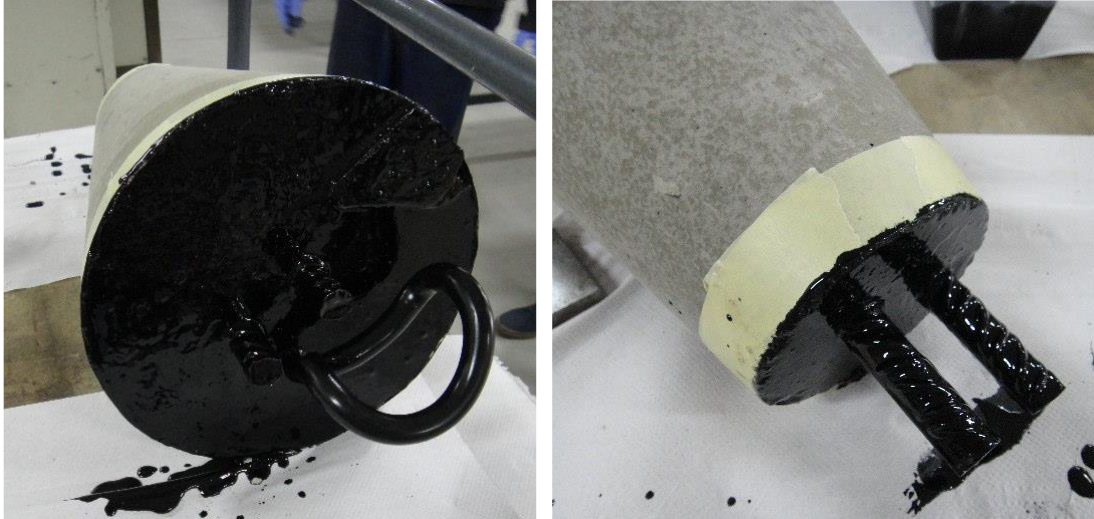
To ensure that the penetration of chlorides only occurs in the lateral surface of the cone, the upper and lower faces have been protected, as well as the sections of corrugated bars that protrude from the concrete with a thick layer of two-component epoxy coating, Figure 2.

Figure 2. Detail of the application of the paint on the bases of the specimens and on the reinforcements.

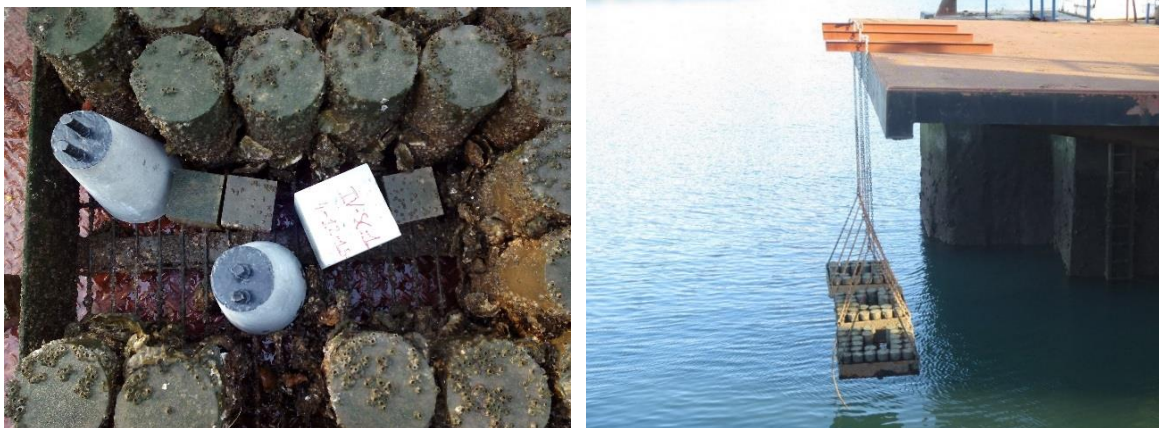
After keeping the specimens in the humidity chamber for 28 days, one of each mix was transferred to the port of Bilbao. There they were distributed on two metal grids together with other specimens from other research centers (Figure 3 left). With the help of a crane, the grilles were suspended a few centimeters from the surface of the sea leaving the specimens exposed to tidal changes for 10 months, (Figure 3 right).

Figure 3. Arrangement and location of test samples in tidal race in the port of Bilbao.

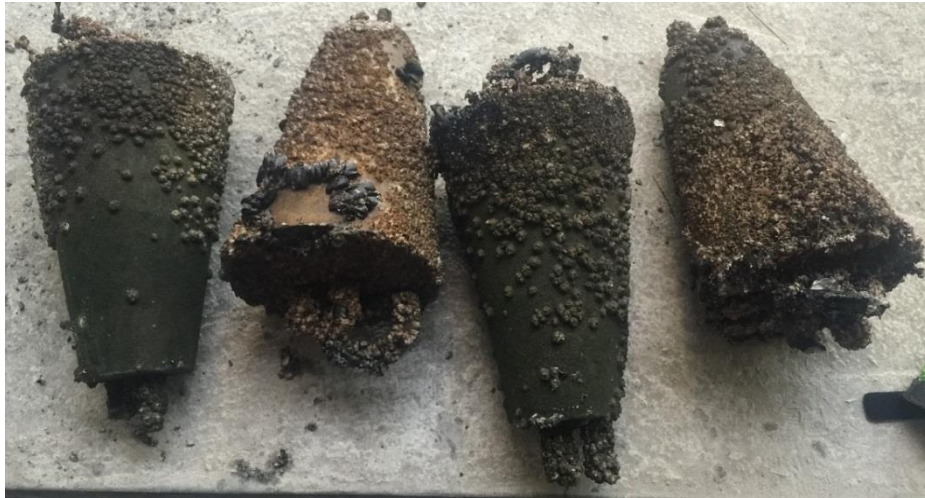
After 10 months, the specimens were removed and moved back to the laboratory. During the visual inspection, the abundant presence of mollusks adhered to the surface of the concrete specimens, the corrugated bars and the steel hook was observed (Figure 4). In the areas where

these colonies were not present, the formation of an organic greenish layer was observed.

Figure 4. Appearance of the specimens after exposure to the weather and tidal cycles.

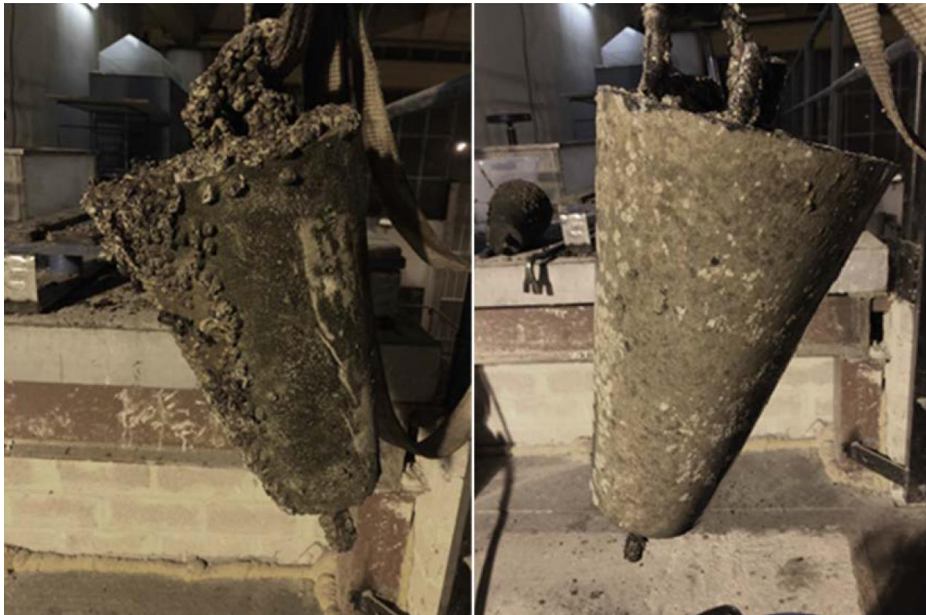
With the help of a crowbar, the mollusks stuck in the concrete were removed, while those attached to the bars and the metal piece were crushed with a hammer. The surface was then rubbed with a scourer to remove the organic layer (Figure 5). Finally, they were rinsed and placed in the oven at 110 ± 5 °C until constant mass.

Figure 5. Appearance of samples before and after cleaning.

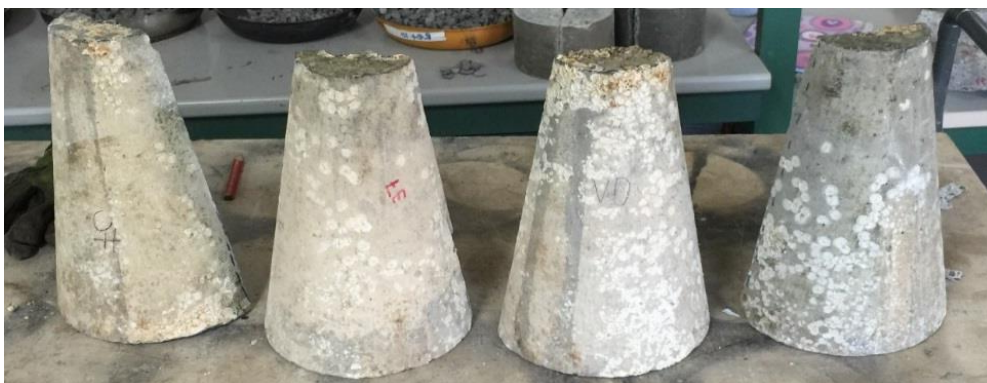
Figure 6 shows the appearance of the specimens after continued exposure to the marine environment and to the tidal race for 10 months, after cleaning the exterior faces and the longitudinal cut.

Figure 6. Exterior of conical specimens SCC-DC-LF, SCC-DC-CS, SCC-DC-FA and SCC-SC-CS after exposure to contact with seawater.

The absence of pathologies on the outside of the cone trunks can be verified as chipping or loss of material, while, in Figure 7, the intact state of the bars inside the concrete can be seen after making a longitudinal cut in the specimens. Direct exposure to seawater has not negatively affected embedded steel bars, with no deterioration observed. It should be noted that in the narrowest area of the specimens, the minimum coating thickness is only 10 mm.

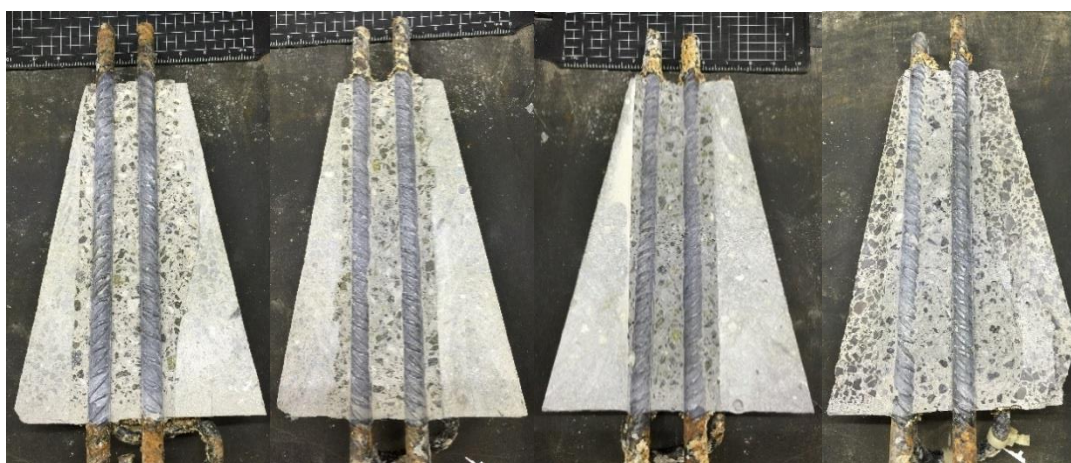
Figure 7. Inside of the SCC-DC-LF, SCC-DC-FA, SCC-DC-CS and SCC-SC-CS specimens after exposure to seawater.

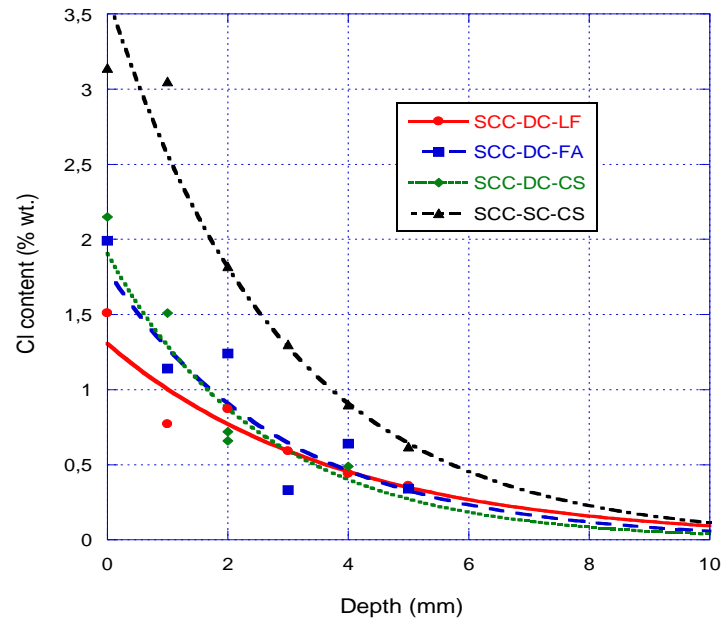
Figure 9 shows the chloride concentration in the concrete obtained by microanalysis carried out from the outermost surface to the area where the steel bars are embedded. It is observed, as expected, that the highest concentration is found on the surface. Of all the samples, the SCC-SC-CS has a much higher concentration of chlorides, while samples made with natural aggregates, despite containing different additions, have a very similar chloride content.

Figure 9. Penetration of chlorides in concrete.

These results agree with the oxygen permeability coefficients (Sosa et al., 2020), being able

to assume that the diffusion is carried out through the capillaries. In all the cases analyzed, it can be seen that, after 6 mm, the concentration of the Cl⁻ ion is less than 0.3%, which is at the limit of the detection capacity of the scanning electron microscope for this element. These results are markedly lower to those reported by C. Medina et al. for a CVC with recycled aggregates (Medina, Sánchez De Rojas, Thomas, Polanco & Frías, 2016).
