Passive seismic monitoring applied to rock block stability in the Montserrat Massif

The Montserrat Massif (Catalonia, NE of Spain) is a natural and cultural heritage where rockfall risk arises. Therefore, a risk mitigation plan is underway, including rockfall monitoring at different scales using different techniques. Particularly, the rock block A3-6, menacing the rack railway leading to the monastery, has been monitored since 2010 by extensometers that show the cyclic movement due to the annual thermal cycle, which is mainly recoverable, but small residual plastic derivations have been detected in a varying amount, along years. At the end of 2021, stabilization work has been carried out. The block has been monitored with passive seismic techniques before, during, and after these works in order to detect signs or evidence of evolving stability similar to previous experiences in the Alps. Two main results have been found. On the one hand, a slight difference in the recorded ambient noise between the potentially unstable block and the rear massif was detected, for both the H/V spectral ratio and the polar spectrogram. A characteristic resonance frequency of the block is observed aro

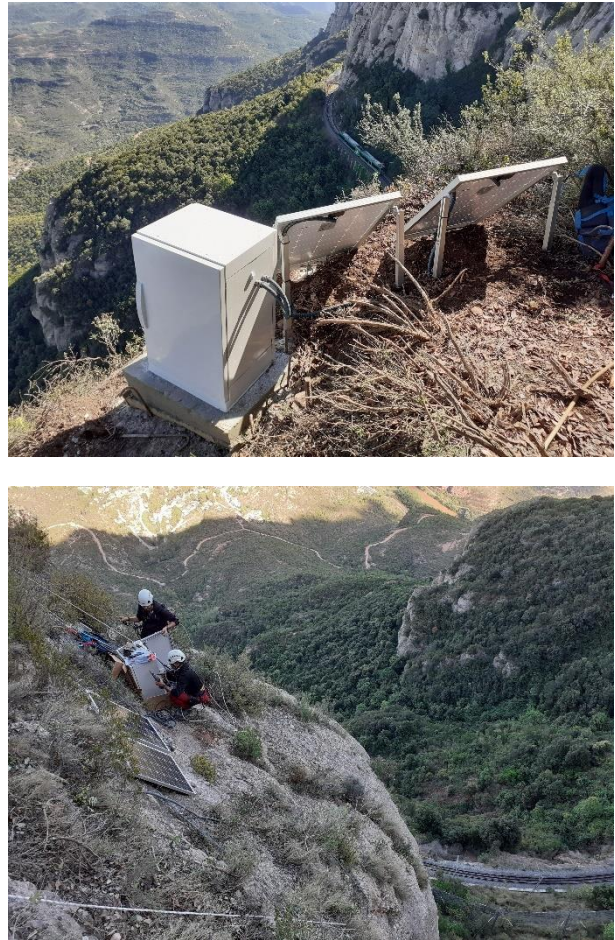
The passive seismic monitoring has been carried out by installing two autonomous seismic stations (Fig. 2), one anchored at the top of the block A3-6 (UTG09) and another one installed at the massif, close to the cliff border (UTG10). Each seismic station (Fig.3) is composed of a Lennartz LE-3D/5S seismometer, a SARA SL03 digitizer, the power supply (battery with solar panels) and the communication system (mobile phone modem). The seismic stations were installed on October 7th, before the beginning of the stabilization works, and were removed on February 9th, when the works had already finished. During all this time the equipment was recording continuously with a sampling frequency of 200 Hz.

Figure 2. Installation on site of the monitoring devices on the massif (upper) and the block (lower).

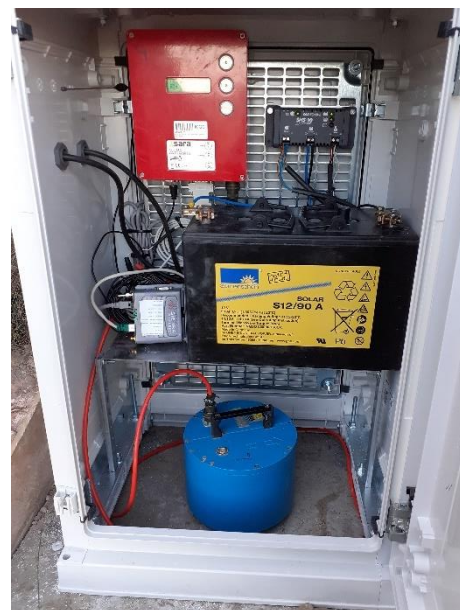
Figure 3. Monitoring equipment of each device: seismometer, recorder, power supply and communications.

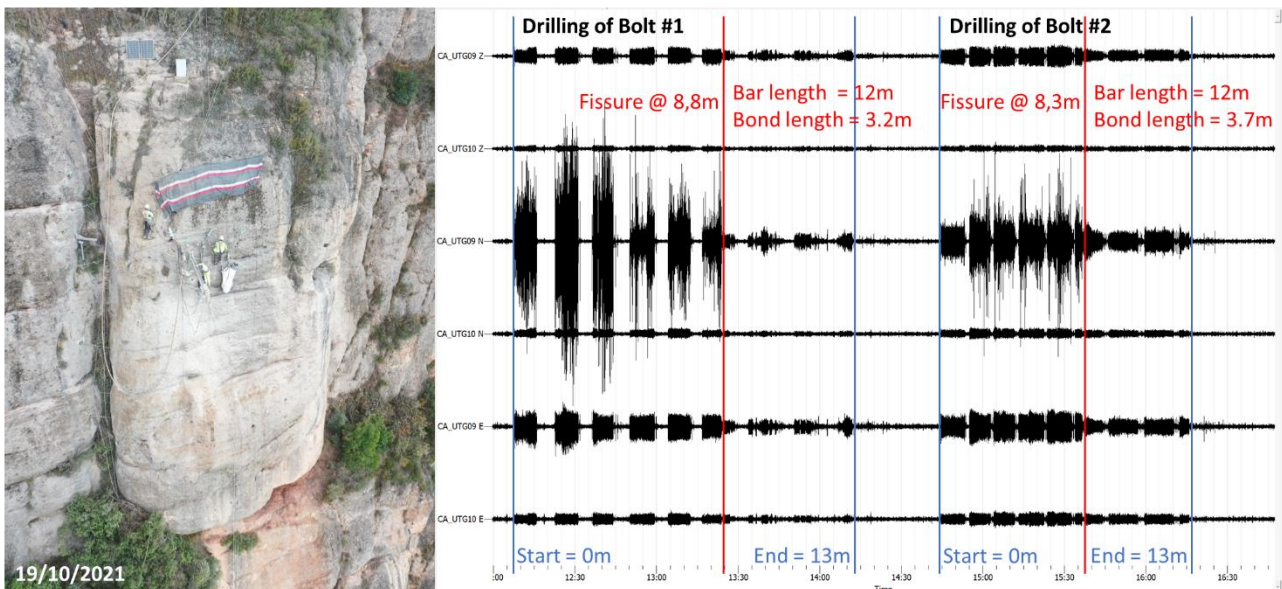
Drilling equipment has a bottom roto-percussion hammer, which acts as a vibration source. Since it travels along the drilling, it allows geophysical exploration of the internal structure of the rock block. As there is one seismometer anchored to the block (UTG09) and another to the massif (UTG10), the passage of the hammer across the joint, from the block to the massif, generates a characteristic signal with decreasing amplitude, depending on the conditions of the crack. This feature was used to aid the detection of the moment when the drilling crosses the joint, marked by the red line in Figure 6. It is worth noting that the A3-6 block is monolithic and the effectiveness of the bolts lies in the fact that they cross the rear fracture with sufficient length in the back massif for achieving grip.

Figure 6. Rock bolt drilling in the A3-6 block, where work on ropes with drilling sled is visible, as well as the seismic sensor on the block. On the right, the vibration registers on the block (UTG09) and massif (UTG10) during the drilling of rock bolts #1 and #2 as examples of the rear joint detection at 8.8 and 8.3 m depth.

The working conditions in the mountain environment are very restrictive. Personnel access is done using ropes, while the transport of materials and machinery must be done by helicopter, as it is placed beyond the reach of conventional cranes on the road. The capacity of conventionally available external cargo helicopters is severely limited. Consequently, the drilling is carried out with a reduced column of about 2 m of run, mounted on a tubular metal structure forming a sled to be moved

manually along the wall of the cliff by means of subsection cables. Under these conditions, it is difficult to ensure the exact drilling direction and inclination and to detect when the rear joint is crossed. In the case of a fissure with a small opening and light filling, it may be impossible to be perceived by the drilling workers.
