Preliminary tests on the UAV-enabled installation of wireless sensors for monitoring inaccessible slopes

Keywords: monitoring, wireless-sensors, tiltmeter, Montserrat massif, LEWS

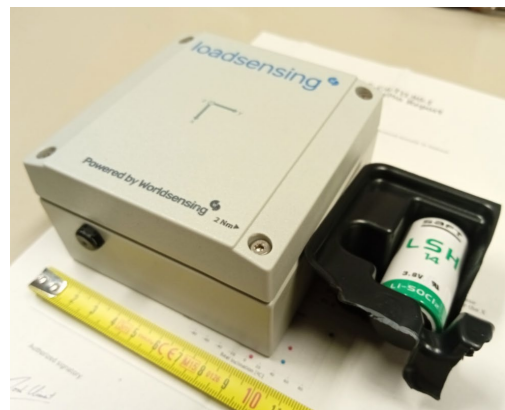
Figure 3. Worldsensing Tiltmeter TIL90-i (weight 440g). The overall box dimensions are 10cm x 10cm x 6cm. With the 3.6Volt battery (right, weight 51g) the sensor can operate several years for a reporting period of 5 minutes and average weather conditions.

The tests carried out make it clear that due to the irregularity of the rock on the decimeter scale, the initial inclination angles of the sensor can be quite high (35° in our tests), which indicates the convenience of using sensors that have wide working ranges. In the study area, in previous years tiltmeters with a $\pm 15^\circ$ range (INC15) were manually placed (figure 2), but for remote installation with a drone it is necessary to use the model with a $\pm 90^\circ$ range (TIL90, figure 3).

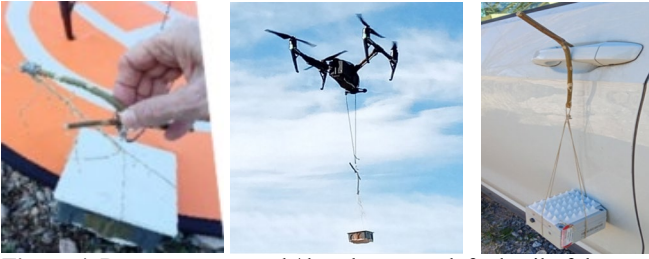
Figure 4. Drone-sensor attach/detach system: left, detail of the “Y” piece; center, sensor hanging from the drone; right, sensor, line and “Y” piece ready for attach.

Although there are release and drop systems on the market, operated remotely, in our case we chose to do the first tests with a passive system for engaging and releasing the sensor. Our design is a wooden “Y”, which hangs from a ring and a line from the drone (figure 4). Since the piece and the line remain with the sensor, it is to some extent interesting that they are biodegradable.

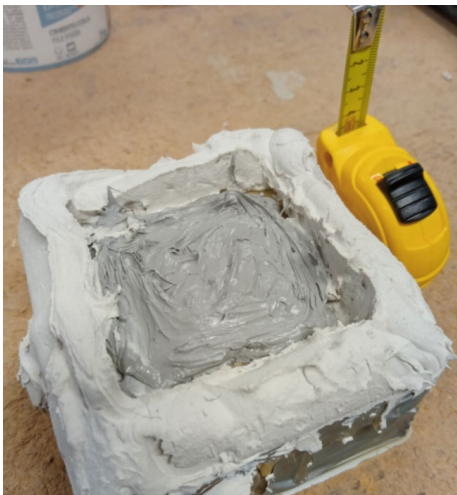
Figure 5. Adhesive layout on the lower base of the sensor.

be seen in figure 7). Good initial adhesion, a long workability period (about 1 hour, without dripping), and a certain rigidity after the drying/setting period were sought. The final solution adopted combines two adhesives on the base (Figure 5): silicone-derived adhesive or mounting adhesive on the central square; a narrow but double-height cord of cement-glue on the perimeter. The center gives a certain initial adhesion, while the cement-glue provides good perimeter contact, with little deformability when it has dried.

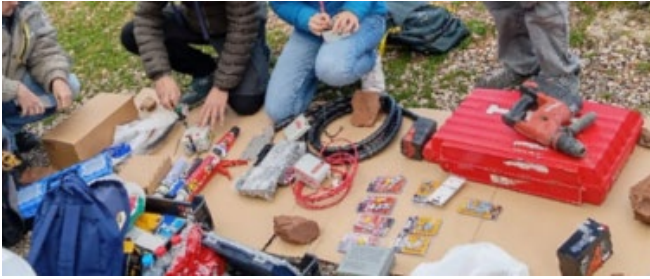
Figure 7. Configuring the sensor and preparing the adhesive.

Figure 7 shows the work area for configuring the sensor and preparing the adhesive, whereas figure 8 shows a detail of the initial configuration of a sensor.

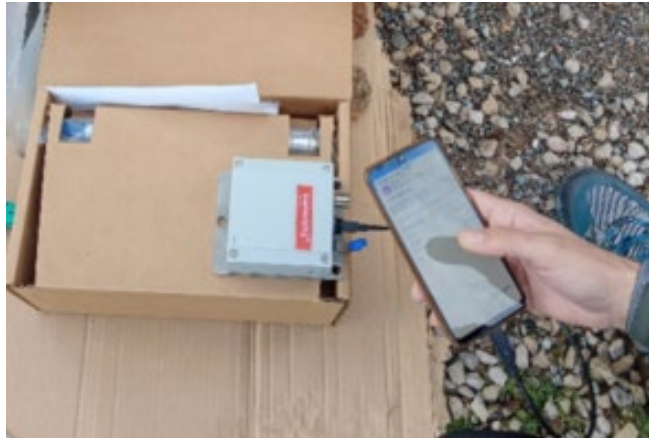
Figure 8. Initialization of an INC15 tiltmeter using an App from the mobile phone.

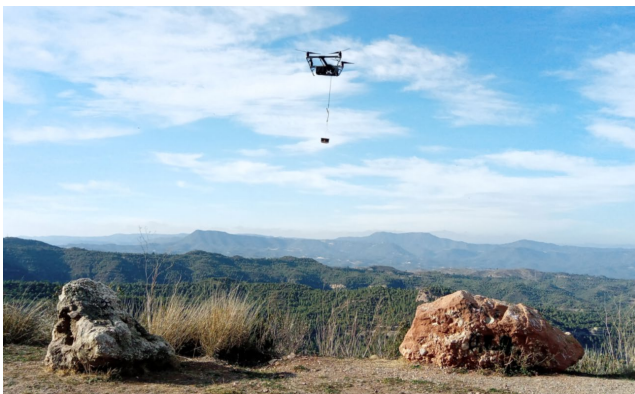
Figure 9. Controlled tests on breakwater blocks, January 2024. View of the drone approaching the blocks.

Figure 9 shows the drone approaching the test blocks, and figure 10 shows some of the first landings, with various inclination angles.

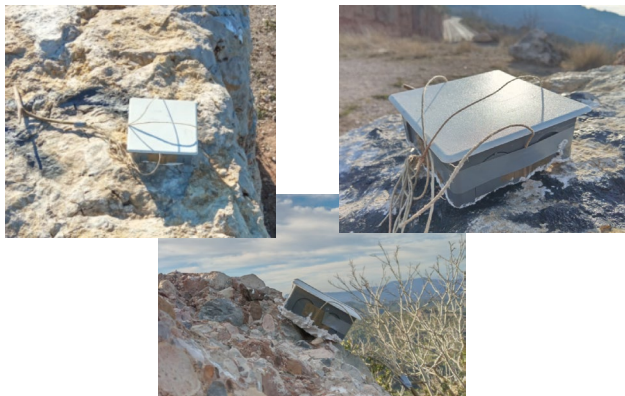
Figure 10. January 2024, first landings with dummy boxes and adhesive. The boxes were left with inclination angles of 5°, 11° and 35°, respectively.

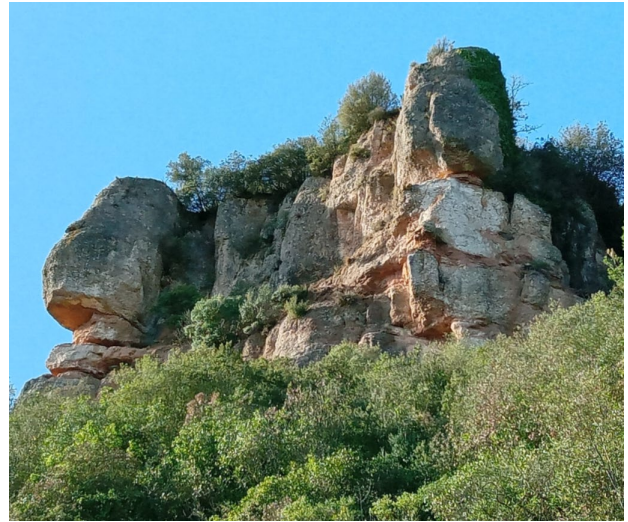
Figure 11. Advanced tests in a block representative of the dynamics of rockfalls in the study area, February 2024. The "Panxo-A" block is the one on the left, hanging vertically over the BP-1103 highway. The TIL90 tiltmeter has been installed at its summit.

After the success of the first tests, in February 2024 advanced tests were carried out on a real block ('Panxo-A', figure 6 and figure 11). This 'agulla' presents a very common situation in the massif: a large block of conglomerate with the support area reduced by differential erosion of the underlying claystone (mechanism one, Mec1, according to Janeras 2023).

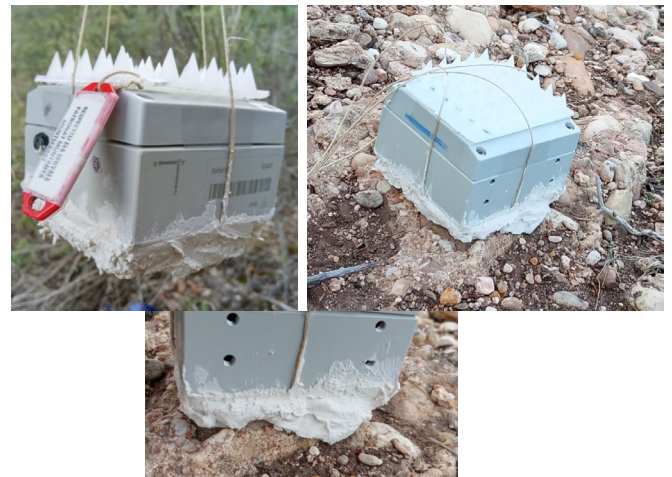
Figure 12. Close-up view of the TIL90 sensor that was installed in the 'Panxo-A' block. Left: sensor hanging from the drone, with identification label (red) and with a system to prevent birds from landing on the equipment (white spikes). Right: sensor once placed on top of the block. Bottom: detail on how, during the drop of the sensor, the perimeter cord of cement-glue (figure 5) has adapted to the irregularity of the underlying rock.

In this case, the TIL90 tiltmeter from Worsensing, shown in figure 12, was installed at the top of the block Panxo-A.

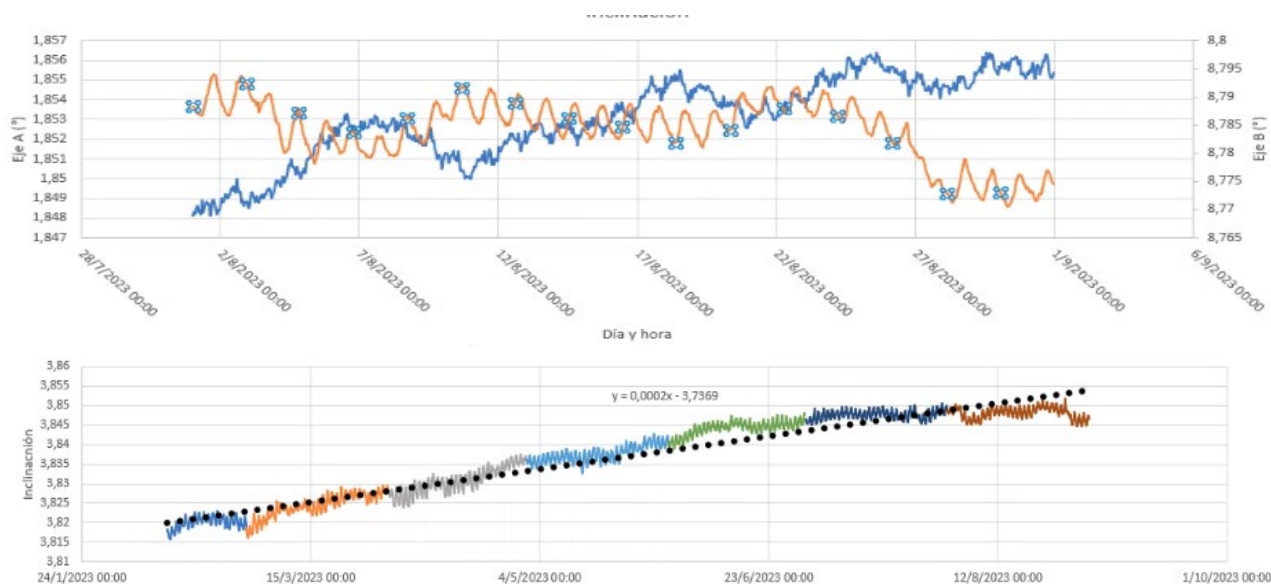
Figure 13. Example of tiltmeter readings in the study area, in the 'Oliver' block (Carballo, 2024). Above: readings on the A axis (blue) and on the B axis (orange) throughout the month of August 2023. Below: readings on the B axis throughout the months of February to August 2023.

Once installed, clinometers provide very useful information to monitor the behavior of the block or element on which it is installed. As an example, Figure 13 shows the evolution of the readings from a wireless inclinometer in the study area. The influence of daily changes in temperature can be seen (upper graph) and also a seasonal change or trend (lower graph), partially recoverable when completing the annual cycle (Carballo, 2024).
