# Crossing a landslide area by a motorway

## ABSTRACT

A 1.5 km long stretch of a motorway built at midheight of a valley eroded by an intermittent river, was almost completed in 2009. Budgetary restrictions led to a halt in construction. In the period 2009-2018, the motorway experienced severe damage, concentrated in three tributary shallow valleys, where the motorway was supported by compacted soil embankments.

The “valleys” were, in fact, ancient landslides reactivated by the weight embankment of the embankment. The damaged embankments were substituted by bridges supported by pile foundations designed to resist the thrust of the active landslides. The bridges were completed by pile walls to improve the stability of the landslides. The construction of the wide roadway platform (40 m) required excavations at the mountainside, embankments at the riverside, additional stabilizing measures by anchored resisting walls, and systematic drainage.

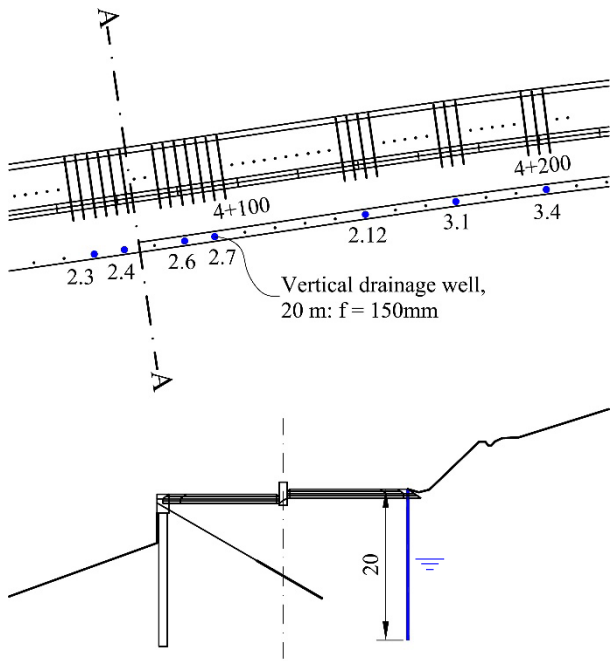
**Figure 15.** Pile wall and vertical drains between pK 4+020 and pK 4+210. Plan view and cross-section A-A.

Figure 18 shows the measured water level in some drains protecting the road platform from pK 4+020 to pK 4+210. The first measurements (January 2022) indicated depths of free water close to 7 m. Two years later the measured depths ranged from 8.5 to 9 m. This range of levels is marked in Figure 15. In the road stretch from pK4+360 to 4+460 all the drains remained dry. This is a positive situation because of the instabilities observed originally in this section.

Figures 15, 16, and 17 show three zones that received this drainage treatment. The figures show also, in a cross-section, the support designed to stabilize the valley slope and the road platform, by means of anchored pile walls, rockfill walls, and anchor rows. The vertical drains, spaced 10 m, have a length of 20 m and a diameter of 150 mm. The performance of this drainage system is variable and can be explained by the heterogeneity and complex geometry of the miocene formation.

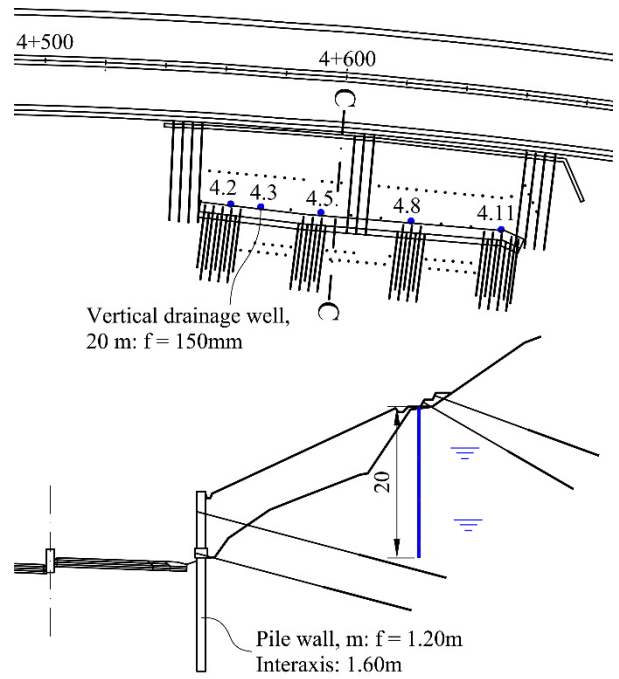
**Figure 17.** Anchored pile wall, anchors and vertical drains between pK 4+550 and pK 4+660. Plan view and cross-section C-C.

Figure 19 shows the measured water depths (February 2024) in drains installed in sections pK4+550 to pK4+660. This is a critical location because of the slope failures triggered by the excavations (mountain side) performed during the initial construction of the

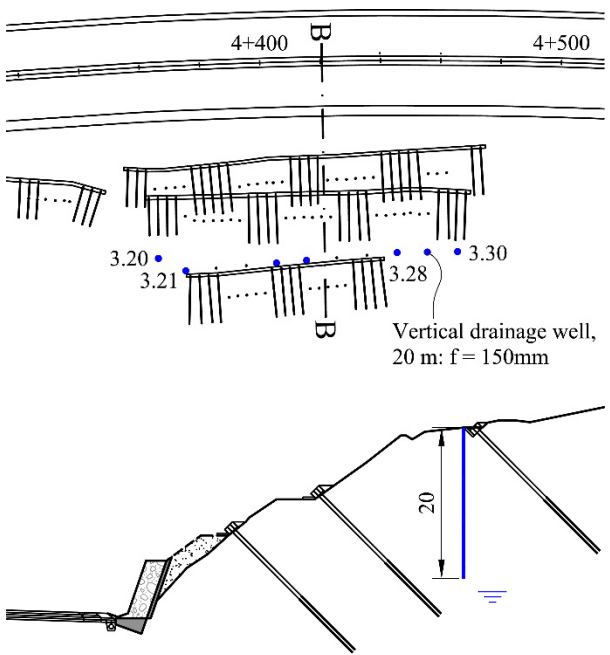
**Figure 16.** Rockfill wall, anchors and vertical drains between pK 4+360 and pK 4+460. Plan view and cross-section B-B.

motorway. The recently recorded water depths in drains vary between 14 m, in half of the protected section, to 5.50 – 7.50 m in the second half (50 m long). This is marked in Figure 16. Overall, the effect of the vertical drains is estimated as a positive contribution to the stability of the road platform.
