Damaged Swedish Buildings

Petter Wallentén¹, S. Olof Mundt-Petersen^{1,2}, K.O. Anders Joelsson² and Mikael Kläth²

¹Division of Building Physics, Lund University, Box 118, SE-221 00 Lund, Sweden,
petter.wallenten@byggtek.lth.se, olof.mundt.petersen@polygongroup.com (Corresponding author)

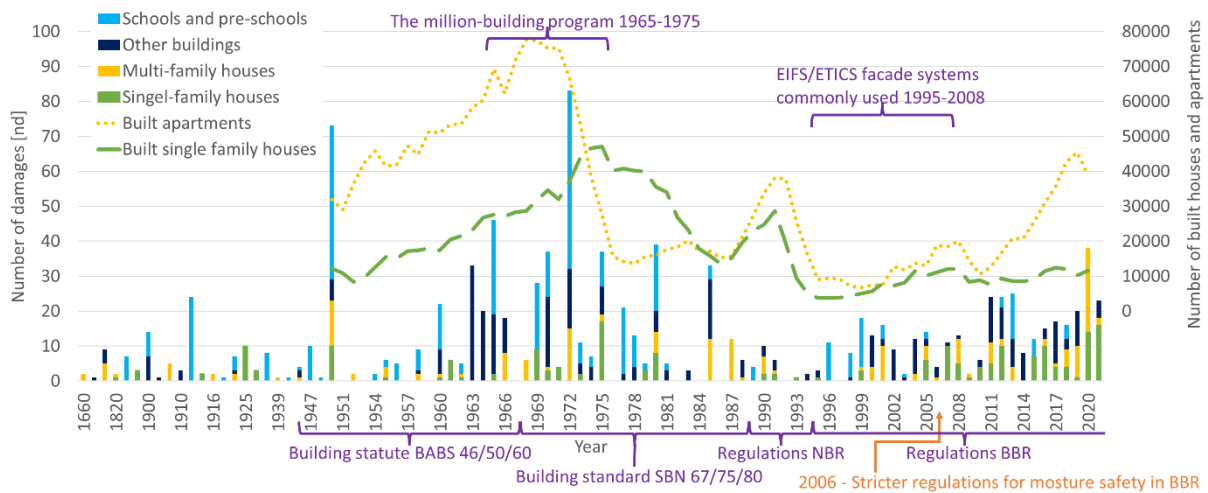
Figure 1. The amount of damage per year in single-family houses (green), multi-family houses (orange), schools and preschools (turquoise) and other buildings (black) compared to actions that may affect the frequencies of damage in buildings and the number of built houses (green line) and apartments (orange line) (SBC 2022).

The year of completion (*Year*) for the investigated buildings, where damages were found, and other relevant data and known activities are shown in Figure 1. In case of a known reconstruction, the year of completion of the reconstruction is registered as *Year*.

The results indicate a relatively high number of damages in older buildings and buildings built in the 60s and 70s, which agrees with the findings of SWDC (1977-2022), Anticimex (2014-2022) and Health Agency of Sweden (2017). This may also be expected due to wear and tear as well as the fact that those buildings are old and assumed to have a higher amount of old, degraded details and building materials compared to new buildings. In agreement with Boverket (2018) and SWDC (1977-2022) the number of damages seems to follow the number of built houses. The results show that the variable *Schools and preschools* and *Other buildings* dominates the number of damages in buildings constructed during the period 1963-1980. Furthermore, the relatively lower amount of damage in *Single- and Multi-family houses* during the 60s and 70s indicate that those damaged buildings could not be directly linked to *The million-building program 1965-1975*.

Besides the high number of damages in 1985 there are a lower number of investigated damages until 1999. The decreasing number of new houses being built or the new standard *SBN 80* could possibly create this positive trend. In the late 90s, after implementation of today's *Regulations BBR*, the results indicate that damages have increased. However, *Multi-family houses* tend to have a flat trend even though the construction increased from 2011. The results indicate that that the amount of damage increases in *Single-family houses* from 2005, despite the number of new houses staying at the same level, which is an opposite finding to the Health Agency of Sweden (2017). They reported a lower amount of damage in buildings completed after 2005 (4,1 %) compared to buildings completed 1996-2005 (9,5 %). It is possible that the

The peak in 1950 is explained by that several buildings without a precise known year of built have been estimated to be built around 1950 (+- 5 years). The peak in 1972 include two investigations of 24 nd and 33 nd. The deviations 1950 and 1972 show that more recorded damages are needed to make a more representative database. The introduction of *Stricter building regulations for moisture safety in BBR* does not appear to have had a positive effect.

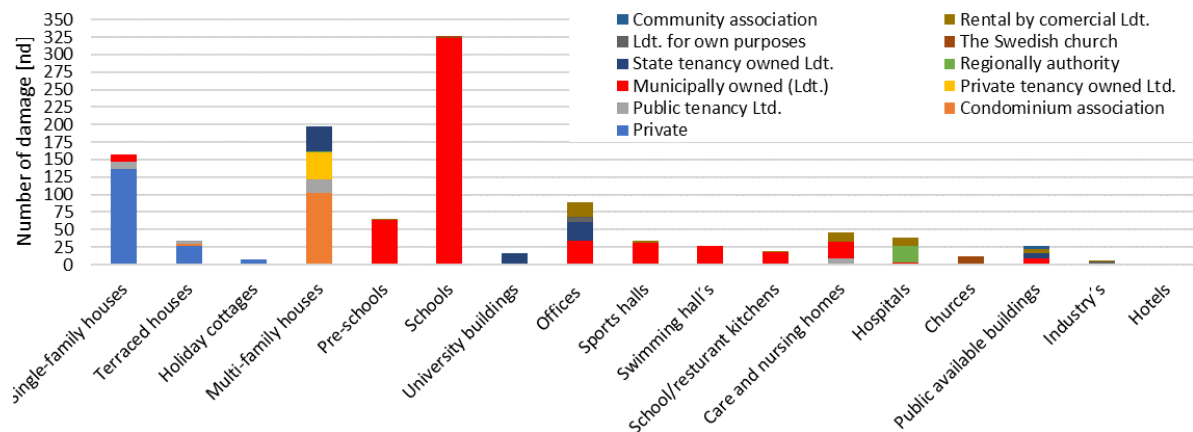
Figure 2. The different types of buildings (x-axis) and its ownership (colors) where damages were noticed.

The distribution of the ownership and types of buildings where damages were noticed are presented in Figure 2. *Public available buildings* refers to museums, restaurants, cafés, shops, club houses etc. Prisons (1 nd) are registered as *Multi-family houses*. Chapels are registered as *Churches*. Religious communities (3 nd) are registered as *Community associations*.

Figure 2 shows an example of how different parameters, Type of building and Ownership, could be crossed-compared and analyzed. According to the damages, *Schools* (326 nd) and *Preschools* (66 nd) dominate the type of buildings where damages were found (in total 392 nd). Therefore, *Municipally owned* properties (red) dominate the number of damages (542 nd). *Single-family houses* (157 nd), *Terraced houses* (34 nd), and *Multi-family houses* (198 nd) also show a high number of damages (in total 389 nd). A notably high number of damages were found in *Public tenancy* (grey, 10 nd) and *Municipally owned* (red, 10 nd) owned *Single-family houses*. In contrast to statistics from Boverket (2018) and SWDC (1977-2022) a higher amount of damages in *Multi-family houses* compared to *Single-family houses* was noticed, which may depend on that private owners often are treated as low-priority customers.

The number of damages in *Multi-family houses* in *Condominium association* buildings (orange, 103 nd) is higher than the number of damages in *Public tenancy owned Ltd.* (grey, 19 nd), *Private tenancy owned Ltd.* (yellow, 39 nd) and *State tenancy owned Ltd.* (dark blue 36 nd). Although a possibly skewed distribution of the potential customers, our results are in accordance with Boverket (2018) but at the same time is opposite to the Health Agency of Sweden (2017) stating that private owned condominium buildings have a lower number of

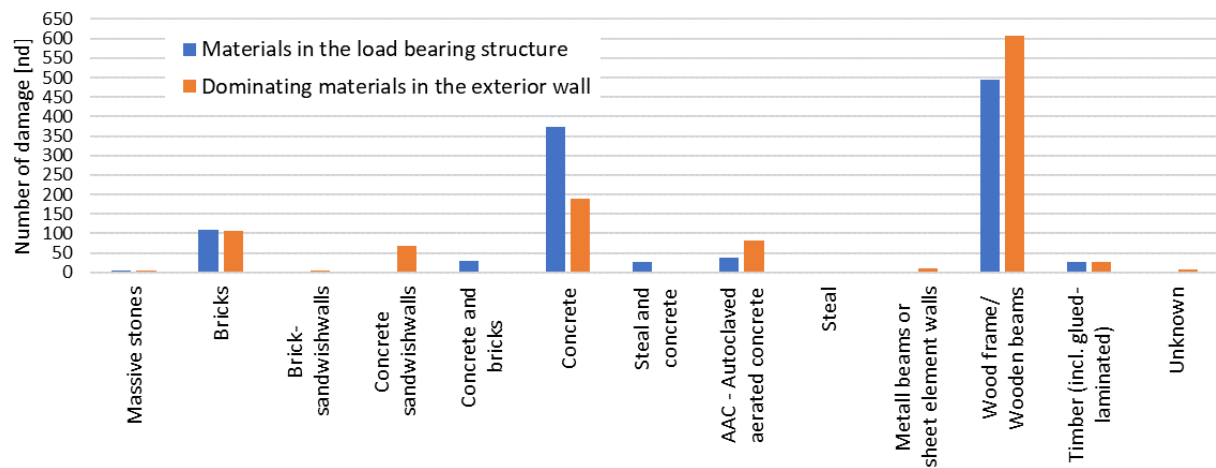
Figure 5. The distribution of damages in buildings with different load bearing structures and wall designs.

The number of damages in buildings with different materials in the load bearing structure and materials in the exterior wall (excluding insulation) are presented in Figure 5.

It is difficult to draw conclusions from the results in Figure 5 since there is no available information for the number of different built structures and wall designs in Sweden to compare with. The number of damages in buildings with a *Wood frame* or *Wooden beams* compared to
