EFFECT OF PLY THICKNESS ON DYNAMIC DAMAGE PROGRESSION IN CROSS-PLY LAMINATES UNDER LOW-VELOCITY IMPACT

Summary: *In this study, we have conducted in-situ LVI experiments on cross-ply CFRP beams having stacking layups $[0_4/90_4/0_2]_s$ and $[0_2/90_2/0_2/90_2/0_2]_s$. The progression of damage is observed through high-speed photography. In addition to LVI, quasi-static indentation (QSI) experiments are performed to reduce challenges in monitoring damage progression during the short impact loading interval. QSI experiments provide magnified in-situ observations on the free edge of the beam using a traveling digital microscope. Numerical simulations of these experiments are carried out using the finite element method in ABAQUS/Explicit. The orthotropic constitutive material model, predicting fiber and matrix damage initiation and evolution, is implemented through a VUMAT subroutine. The comparison between numerical simulations and experimental observations allowed us to investigate the influence of ply clustering on the LVI-induced damage mechanisms.*

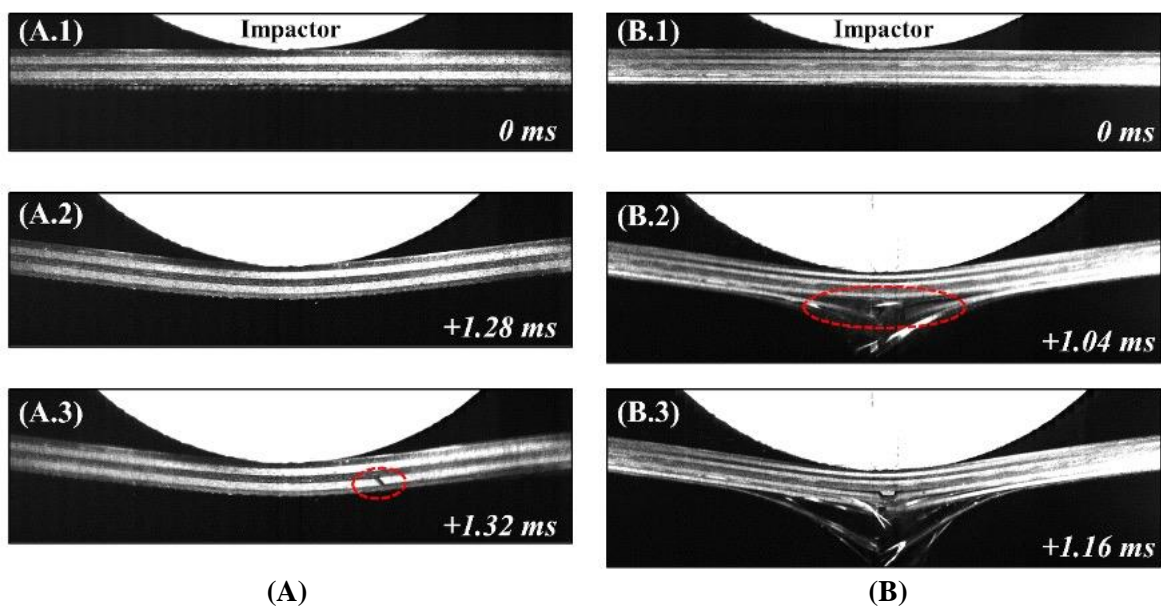
Figure 3: High-speed camera photographs showing the damage progression of (A) $[0_4/90_4/0_2]_s$ and (B) $[0_2/90_2/0_2/90_2/0_2]_s$ specimens under low-velocity impact loading.

Figure 3(A) and Figure 3(B) show the damage progression of the impact-induced matrix cracking and delamination damage in $[0_4/90_4/0_2]_s$ and $[0_2/90_2/0_2/90_2/0_2]_s$ specimens, respectively. These images, captured using a high-speed camera, depict three frames from the moment of initial contact to the observation of final state of the damage.

The reference frame, taken as the initial contact between the impactor and the composite specimen, is shown in Figure 3(A.1) and Figure 3(B.1), with a time of 0 ms. In the $[0_4/90_4/0_2]_s$ specimen, initial matrix damage is observed at 1.32 ms on the right-hand side of the beam as a

diagonal crack inside the lower 90° group of plies, inclined at approximately 53° with respect to the horizontal in Figure 3(A.3). The delamination initiated from the upper tip of the diagonal crack propagated towards the impactor, while the lower tip initiated a delamination that propagated towards the boundary region.

For the $[0_2/90_2/0_2/90_2/0_2]_s$ specimen, no visible damage is observed prior to 1.00 ms. However, at 1.04 ms, sudden failure occurs, including matrix cracking, fiber breakage, and delamination, within the lower 0° and 90° plies beneath the impactor, as shown in Figure 3(B.2). This matrix cracking, coupled with fiber breakage and delamination, progressively propagates to the adjacent upper plies as the impactor moves downward. Figure 3(B.3) shows this propagation of damage towards the upper regions near the second 90° layers at 1.16 ms. The specific sequence of damage modes could not be observed at this capturing rate.

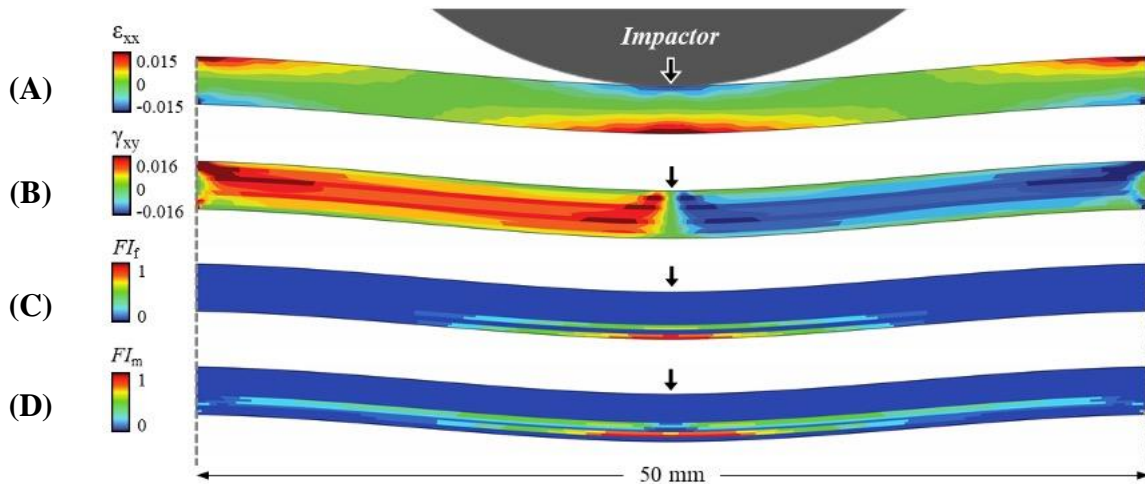
Figure 8: (A) Longitudinal strain (ϵ_{xx}) and (B) transverse shear strain (γ_{xy}) fields, and (C) distribution of failure indices along the $[0_2/90_2/0_2/90_2/0_2]_s$ specimen prior to damage.

Figure 8 depicts the full-field ϵ_{xx} and γ_{xy} strain fields, and the distribution of fiber and matrix failure indices across the $[0_2/90_2/0_2/90_2/0_2]_s$ specimen prior to damage. Similar to the preceding layup, Figure 8(A) displays areas of elevated ϵ_{xx} values concentrated just beneath the impactor and in upper regions adjacent to the boundaries. γ_{xy} field in Figure 8(B) exhibit elevated values near boundaries and within a cone-shaped region beneath the impactor inside the 90° plies. Fiber and matrix failure index values reaching unity are observed beneath the impactor within the lower group of 0° plies and the upper group of 90° plies, respectively. A simultaneous examination of Figure 8(A), (B), (C) and (D) indicates that failure initiates due to a tensile-dominated stress state, as higher failure index values align with regions of increased ϵ_{xx} .

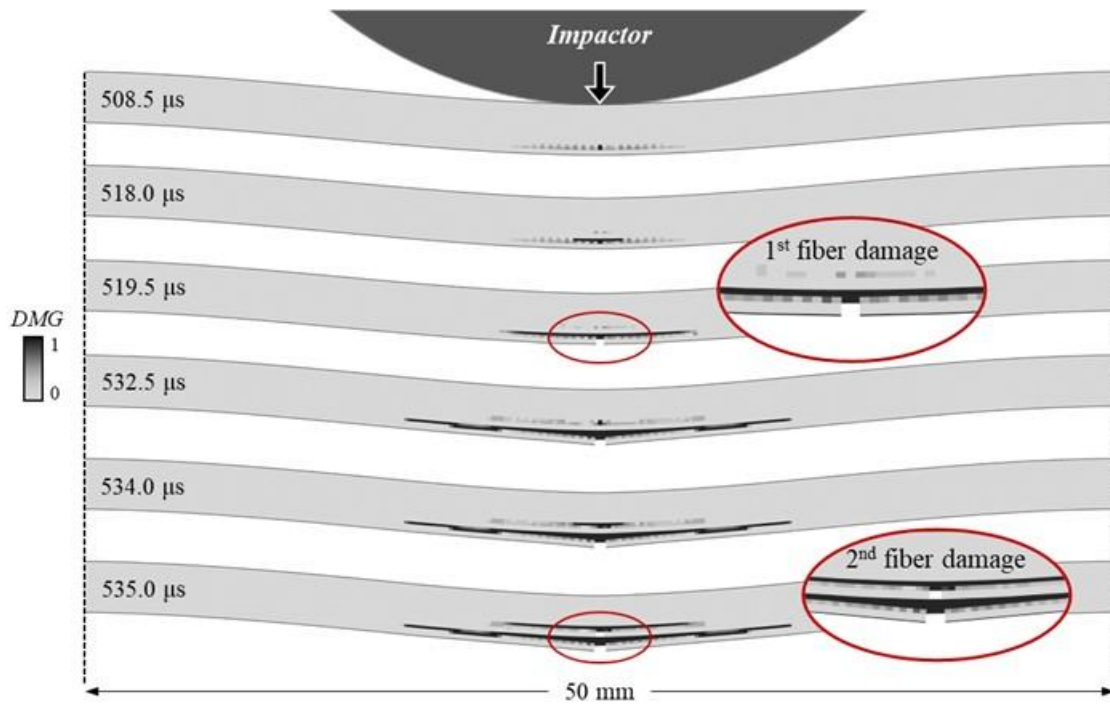
Figure 11: Development of the damage in the $[0_2/90_2/0_2/90_2/0_2]_s$ specimen.

Development of the damage in the $[0_2/90_2/0_2/90_2/0_2]_s$ specimen is presented in Figure 11. The first frame at $580.5 \mu s$ reveals the presence of vertical matrix cracking beneath the impactor, occurring specifically within the lower 90° plies underneath it. By $518 \mu s$, a damage, in the form of delamination along the adjacent elements of the lower 0° plies, propagated towards the boundaries within the lower 90° plies. At $519.5 \mu s$, elements located at the center

of the lower 0° ply group are deleted due to complete fiber damage. As the delamination-like damage propagates to the boundaries, a subsequent vertical matrix crack becomes evident within the adjacent upper 90° plies at $532.5 \mu\text{s}$. Similarly, this matrix crack triggers a sequence of events of delamination-like damage at $534 \mu\text{s}$ and fiber breakage at $535 \mu\text{s}$. The observed damage patterns correspond well with the experimental outcomes presented in Figure 3(B), with the FE simulation revealing a sequence beginning with matrix cracking followed by fiber damage.
