FIRST EXPERIENCES OF CIVIL STRUCTURAL HEALTH MONITORING IN URUGUAY

AGUSTÍN SPALVIER^{*}, AGUSTÍN A. VIDAL^{*}, SANTIAGO GARCÍA[†] MARTÍN
REINA^{††}, JOAQUÍN GONZÁLEZ DE LA BARRERA[†], MARTIN IHLENFELD^{††},
AND FACUNDO NICUESA^{††}

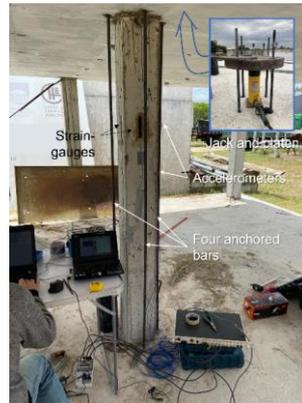
Figure 1: Experimental configuration

The structure is made of a 13 cm thick square concrete top slab supported by nine reinforced concrete columns of dimensions $20 \times 20 \times 200 \text{ cm}^3$, which are founded in another 13 cm thick square concrete slab. The centre column was instrumented and tested, reinforced with four longitudinal steel bars of 12 mm diameter and 6 mm steel stirrups placed every 20 cm. The concrete with which the aforementioned elements were made has a 35 MPa standard compressive strength at 28 days after casting and was provided by a local ready-mix concrete company. See the structure and its instrumentation in Figure 1.

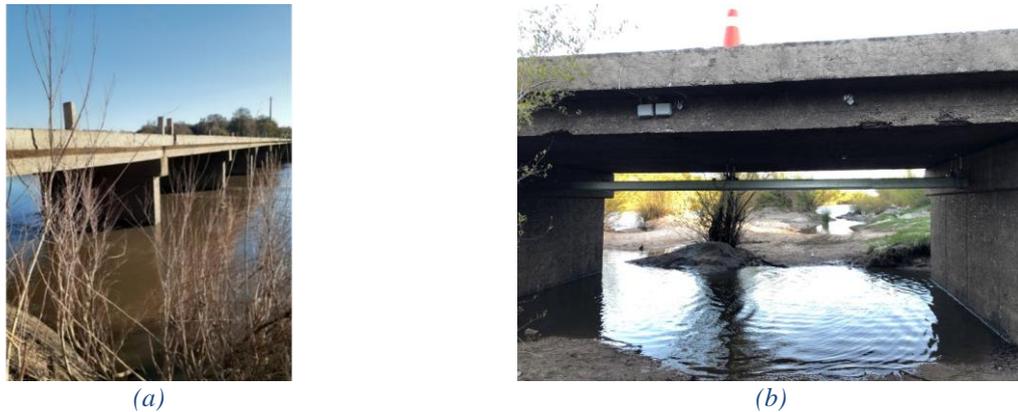
Figure 3: (a)View of Paso San Borja Bridge, and (b) tested span with auxiliary steel beams beneath the deck.

Paso San Borja is a bridge over the Yi River in central Uruguay. The bridge deck consists of 10 slab spans, with each span being independent and simply supported on the piers using 5 cm wide neoprene strips. See Figure 3. These strips consist of two 1.5 cm thick bands with a steel plate between them. The roadway width is 5.00 meters, with two sidewalks of 70 cm each. The deck's thickness is 40 cm, and the distance between pier axes in all spans is 8 meters. On the deck's surface, there is a concrete pavement with an average thickness of 5 cm. Intermediate piers are concrete walls of 40 cm of thickness with a 50×60 cm rectangular beam on the top where the neoprene supports and the deck rest. Both abutments consist of reinforced concrete walls. The geometry of the foundations is unknown because they are underwater. A structural condition survey found that there were no pathologies compromising the safety of the structure and the average conservation state of the structure was acceptable. However, in some areas, remediation actions were recommended, and it was recommended that these pathologies be monitored.

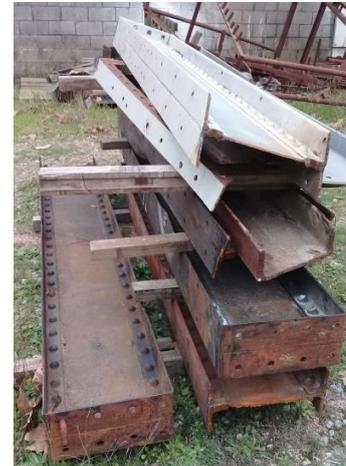
Figure 10: Stringer beams analysed in laboratory.

As for the stringer beam, it was positioned rotated 90 degrees around its axis to study flexural vibration around its minor axis. It was mounted on a pair of metal cylinders on both ends, simulating a simple supported configuration.
