STATE SPACE SYSTEM IDENTIFICATION AND IMPACT AIDED DAMPING RATIO ESTIMATION FOR A STRENGTHENED STONE MASONRY BUILDING

Key words: System Identification, Free Vibration Response, Impact Excitation, Stone Masonry, Seismic Strengthening, Modal Frequency, Damping Ratio.

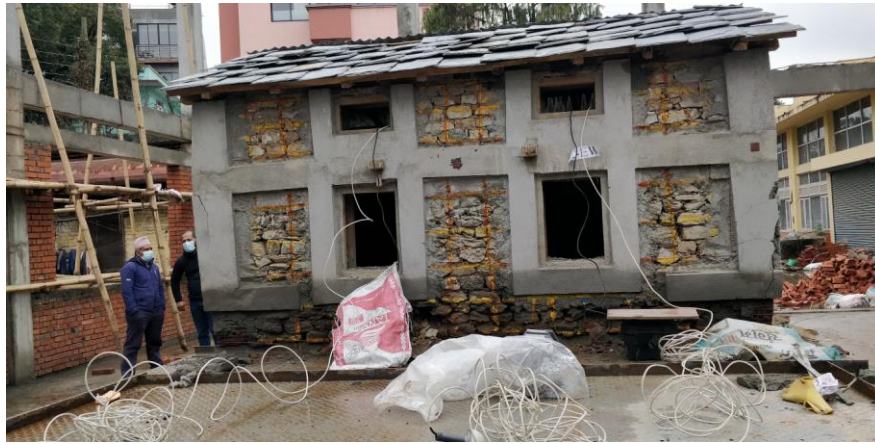
Figure 1: Instrumentation for vibration recording.

openings resembling windows in the long wall direction and two openings in the short wall direction. We deployed three triaxial ETNA-2 accelerometers manufactured by Kinematics Inc., California. Time synchronization was done using externally connected GPS antennas. Vibration records were taken with several gentle impact blows and a few strong blows to induce damage to the structure. Vibration records were taken for 30 minutes under each impact at the sampling frequency of 100 Hz. Figure 1 shows an example of accelerometer setup for vibration recording. Although mounted on the table, one of the accelerometers drifted remarkably, and hence input-output system identification was not possible. Figure 2 shows the impact testing setup together with the impact hammer and table platform. The larger opening side is also shown in Figure 2. Seismic strengthening is provided in the model by deploying wire meshes and occasional ties to connect interior and exterior meshes.

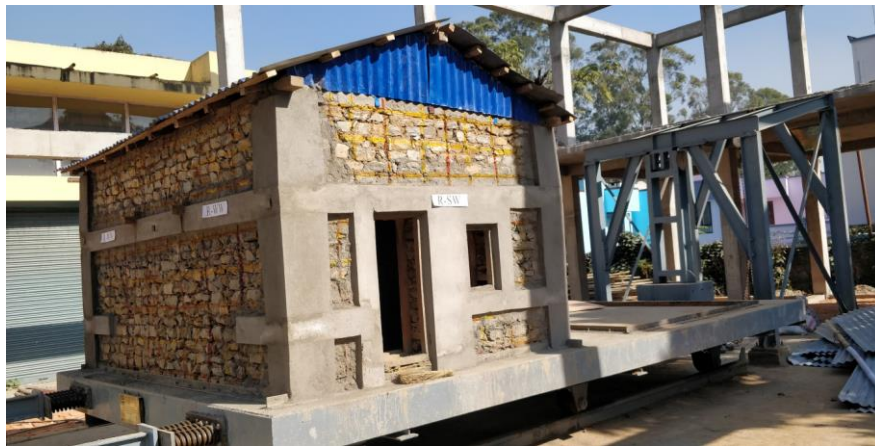
Figure 2: Test setup showing impact hammer (right) and strengthened model.

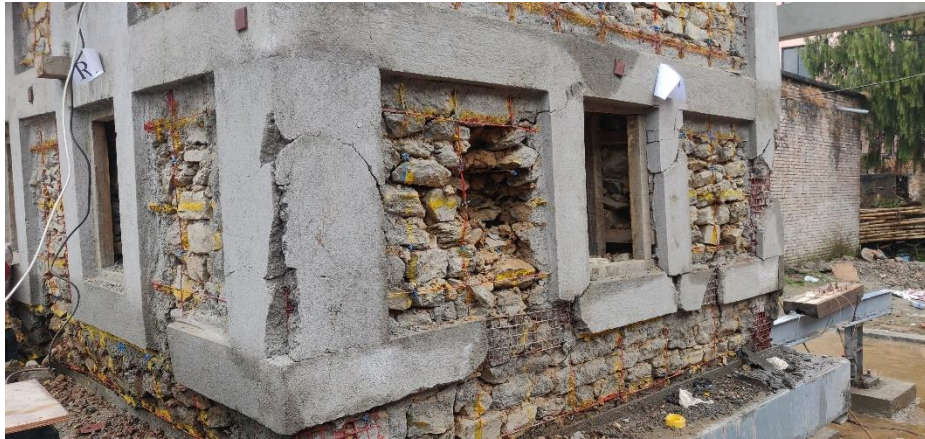
Figure 7: Impact aided damage to the specimen.

Several impact blows were deployed to the table and damage was induced to the specimen. Damage to the structural wall was observed in several locations as shown in Figure 7. Similarly, wire meshes were broken in several locations, which confirms the damage occurrence and stiffness reduction. The FRF after damage is shown in Figure 8. The figure shows a shift in the fundamental vibration direction together with a significant reduction in the frequency. The summary of vibration characteristics after damage is presented in Table 2. The damping ratio is found to be increased significantly after damage. A considerable reduction along the longer wall side is attributed to the greater intensity of the damage. A 54.45% reduction in frequency is envisaged after the impact aided damage. However, we were not able to quantify the force application so as to quantify the level of frequency reduction given the impact loading. On the other hand, the Y direction observed only a 20.62% reduction in the first mode frequency, which is attributed to lesser damage to the short wall direction. We have reported the first three vibration mode results only because higher modes except for the first three are not reliably estimated as shown in Figure 6.
