A COMPARISON BETWEEN EMPIRICAL PROCEDURES FOR THE DEFINITION OF VULNERABILITY CLASSES OF MASONRY BUILDINGS: APPLICATION TO FIVE HISTORICAL CENTRES STRUCK BY 2016 CENTRAL ITALY EARTHQUAKE

YLENIA SARETTA^{1*}, LUCA SBROGIÓ¹ AND MARIA R. VALLUZZI¹

¹Department of Cultural Heritage (dBC)
Università degli Studi di Padova
Piazza Capitaniato 7, 35139 Padova, Italy
e-mail: ylenia.saretta@unipd.it (*corresponding author), luca.sbrogio@phd.unipd.it,
mariarosa.valluzzi@unipd.it

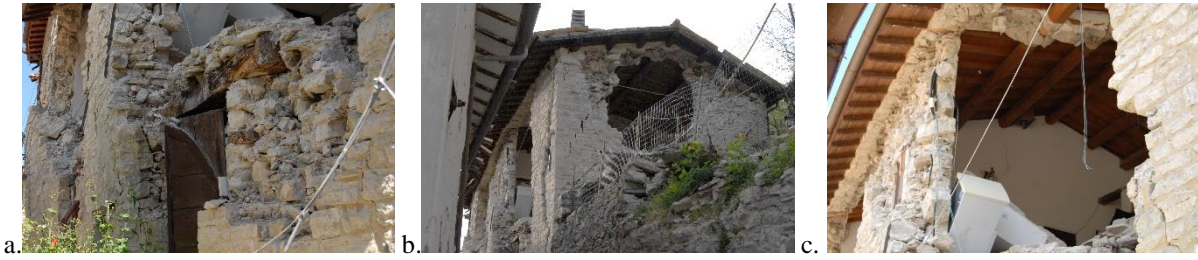
Figure 3: Examples of poor seismic behaviour in a strengthened masonry building, CSN: a) Not effective tie rods on bad quality masonry; b) overturning of last storey and c) of internal bearing walls due to r.c. curbs and to excess of stiffness and weight of reinforced timber roof

The application of the literature conversion rules to the data set (Figure 2) has highlighted their limits in the vulnerability classification. In fact, these procedures do not take into account the influence of structural strengthening interventions applied on buildings in a recent past, observing only the presence of tie rods or tie beams. The effectiveness of these connection systems on seismic behaviour is taken for granted, especially if they are associated to rigid diaphragms (cfr. Table 1 and 3). However, observations demonstrated that the effectiveness of tie rods is limited by masonry quality at the anchoring (Figure 3a, see also [25]), while r.c. curbs on weak masonries cause crumbling, overturning and sliding of the walls (Figure 3b, c) [21].

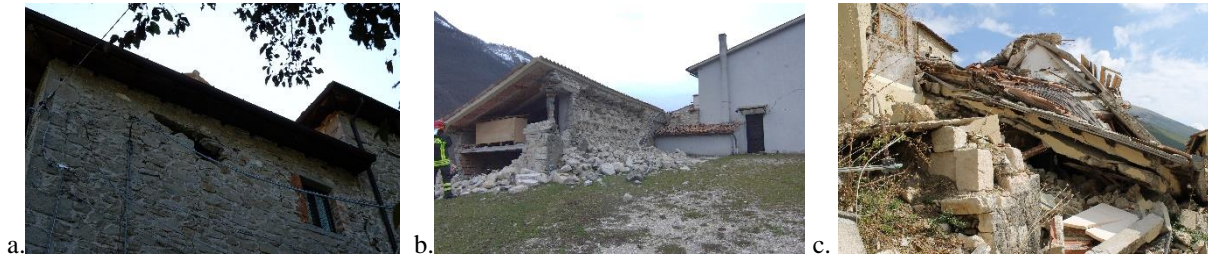
Figure 4: Examples of damage due to rigid roofs: a) Slip of the roof and horizontal arch (VZZ); b) Masonry leaves separation and local overturning (CSN); c) Total collapse due to crumbling of masonry (CMP)

Moreover, according to the conversion rules, the unconditional favourable effect of rigid slabs on a building's seismic behaviour yields to classes B or C. In the authors' opinion, on the basis of the empirical evidence, that could be true only in case of low levels of seismic input (Figure 4a), while near the epicentre rigid diaphragms on poor masonries induce crumbling phenomena and a building's collapse (Figures 4b and 4c). Therefore, the vulnerability increases, and the building is prone to suffer of a higher damage, as already appeared after the 1997 Umbria-Marche earthquake [27].

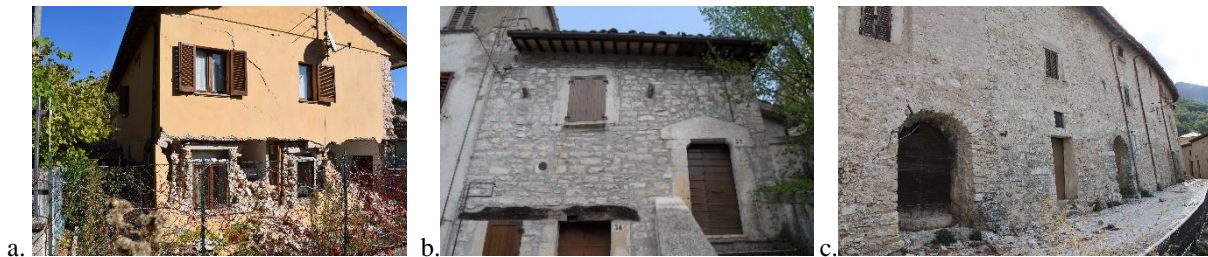
Figure 5: a) Class A building: poor masonry quality and floors replaced with rigid ones (MCC); b) C class building: random layout limestone masonry reinforced by deep repointing with cementitious mortar (CSN); c) D class building: random layout limestone masonry reinforced by grout injections and r.c. jacketing (internal side) (CMP)

Another problem of the literature rules is the limitation to the first three classes, among which class C generally defines buildings with artificial blocks or dressed stone masonries; this classification needs to be widened to better explain the real seismic behaviour. The issue has been recently discussed by the authors [21,23], underlining that buildings with holistic interventions could be actually described by class D, typical of new buildings (§1.1), while partial interventions yield class A. Original buildings without strengthening interventions (stone masonries and timber floors) belong to class A, such as buildings with original unreinforced stone masonries and replaced diaphragms with rigid or semirigid ones (Figure 5a). As well as recent buildings (Table 5), deep repointing and thick cementitious plasters on bearing walls allow to reach class C (Figure 5b), while core interventions, such as grout injections and r.c. jacketing, could lead to class D, regardless floors' stiffness (Figure 5c). Class B is not explicitly defined, but it expresses the possible range of vulnerability thanks to the structural details and the masonry quality.
